FUNDY TIDAL ENERGY DEMONSTRATION PROJECT
Environmental Effects Monitoring Report

Side Scan Sonar Survey Final Monitoring Report

**Environmental Monitoring of Seabed Sediment Stability,
Transport and Benthic Habitat at the Reference Site and
the Vicinity of the NSPI TISEC Location
in the Minas Passage**

March 17 /2011

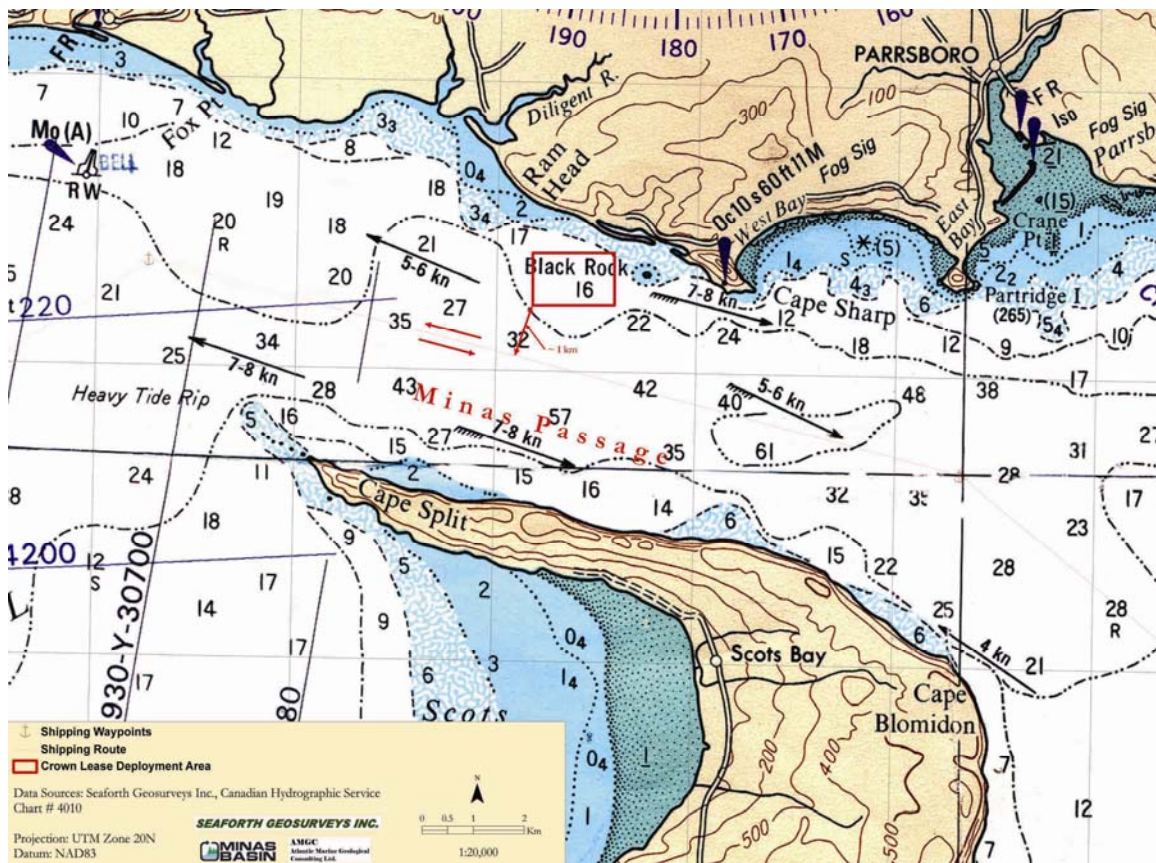
Figure 1 A section of Canadian Hydrographic Chart 4010 of Minas Passage, inner Bay of Fundy. The TISEC demonstration Crown Lease Area lies in the northern part of Minas Passage (red box).

The Canadian Hydrographic Chart for Minas Passage is Chart # 4010 (Figure 1). The sparse bathymetry presented on this chart is in fathoms and it depicts Minas Passage as a narrow body of water constricted to the north of Cape Split as defined by the 20 fathom contour that broadens toward the east to the north of Cape Blomidon. The deepest depths in the Passage are 61 fathoms in the central area to the south of Cape Sharp.

Chart #4010 also shows a number of current velocity vectors with the highest values 7 - 8 knots off Cape Split and Cape Sharp. A current velocity of 5 – 6 knots is plotted on the north side off Ram Head. Minas Passage is the region of highest currents in the Bay of Fundy.

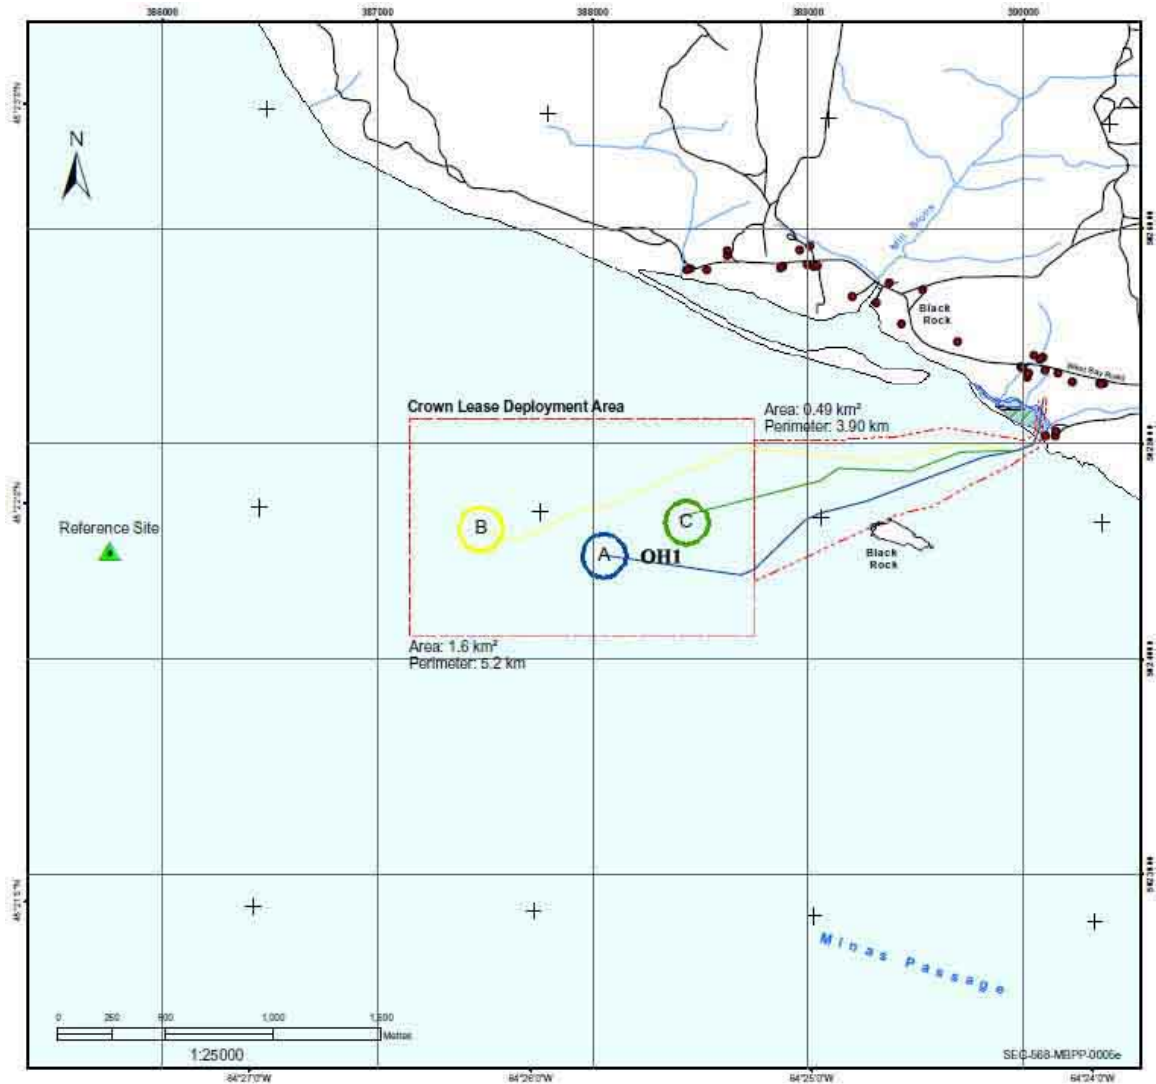
Figure 2 Map of the Crown Lease Area (red dashed box) with the three designated berths (A,B,C), the location of NSPI/OH1(OH1) and the Reference Site (RS) (green triangle) to the west. A new berth has been chosen to the south of C, termed D.

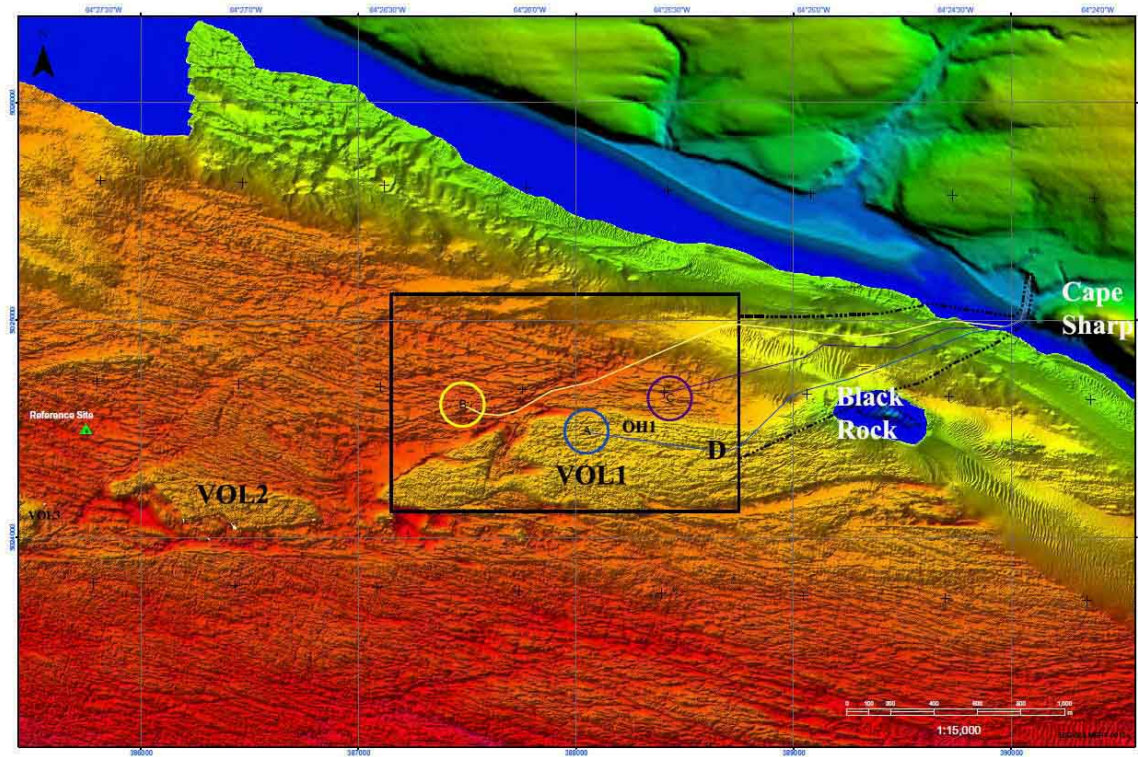
Figure 3 Multibeam bathymetric shaded-relief image of Minas Passage from data collected by the Geological Survey of Canada and the Canadian Hydrographic Service. Superimposed on the map is the Crown Lease Area (black box), the three original test berths, the new berth D, the location of NSPI/OH1, the Reference Site, and the three volcanic platforms of the region.

The regional multibeam bathymetric shaded relief image in Figure 3 shows the water depths of Minas Passage in a colour depth-coded presentation. The image extends from the western Reference Site to Black Rock in the east in the northern region of Minas Passage.

The region of the Crown Lease Area is a rough surface of exposed bedrock ridges and some fields of ripples in gravel. A prominent series of three, 30 – 40 m shallow flat-topped platforms extend to the west from Black Rock and collectively form a ridge that is over 4 km in length. These are areas of volcanic outcrop of North Mountain Basalt on the seabed confirmed by magnetic maps of the region and bottom photographs. For this presentation they are identified as VOL1, VOL2 and VOL3. Directly to the south of the volcanic platform is a prominent linear fault that runs east-west parallel to the trend of the

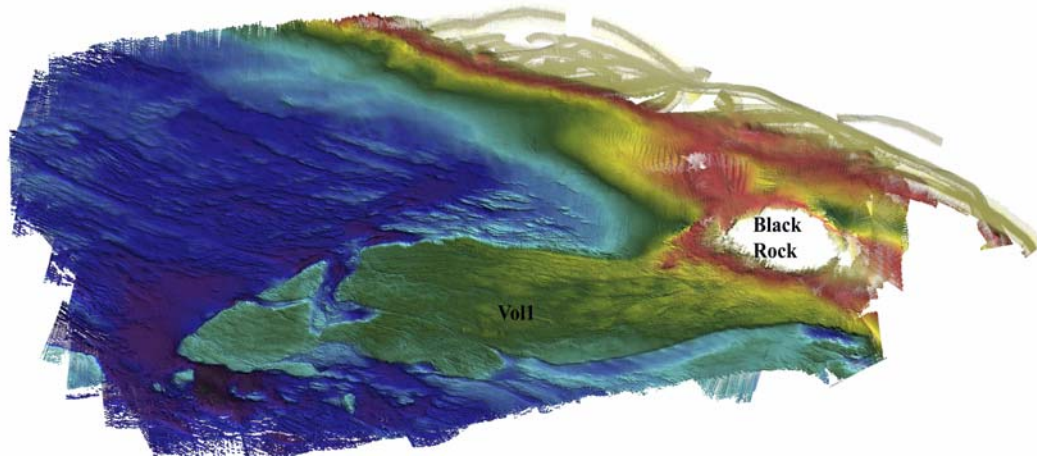
Figure 4 High-resolution multibeam bathymetric map of the area to the west of Black Rock in Minas Passage, produced by Seaforth Geosurveys Inc. This data formed the basis for a variety of seabed maps on backscatter, slope and relief.

The high resolution multibeam bathymetric shaded-relief map, Figure 4 shows the east west trending volcanic ridge as the dominant morphologic feature of the southern part of this study region. Water depths across the ridge show that it is defined by the 30 m contour in the eastern portion near Black Rock, and increases in depth to 35 m at the western tip of the feature. It is a broad flat platform with very minor relief of a few m across its surface and is 500 m wide at its widest location tapering to a triangular-shaped western end. Several broad deep channels occur across the surface of the platform near the western part of the feature and reach over 50 m water depth. A few localized linear depressions occur along the northern flank of the volcanic ridge and appear as erosional moats where seabed scouring takes place. The volcanic ridge protrudes above the surrounding areas by as much as 15 m but averages 5 m in height and has very steep

slopes. The slopes are steeper and higher in the western portion of the platform area. Some local scouring appears to occur around the volcanic ridge flank in the west.

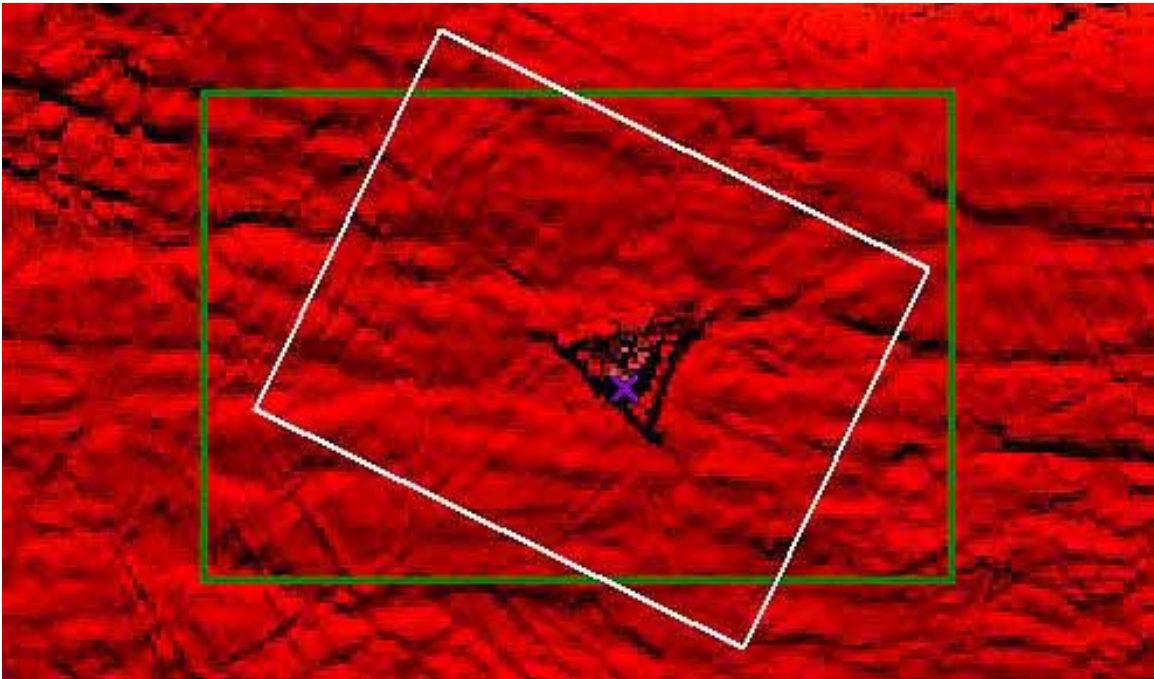
Figure 5 A multibeam bathymetric map of the seabed during the deployed phase of NSPI/OH1 by Seaforth Geosurveys Inc. showing the shape of the gravity platform and the surrounding topography of the seabed. This information provided the exact georeferenced location of the device. X marks the position of the coordinates of the device provided by the Canadian Hydrographic Service. North is to the top of the image and the device is 21 by 25 m in size.

The multibeam bathymetric survey of the device on site (Figure 5) clearly shows its relationship to the topography of the volcanic platform as well as the shape of the gravity base. It lies on the seabed with the apex pointing to the northwest. The frame extensions that hold the eastern two feet can be seen on the east side of the gravity base. The device is 25 m by 21 m in size. For purposes of this discussion, the western most foot is termed Foot 1, the southernmost eastern foot, Foot 2, and the northeastern foot, Foot 3.

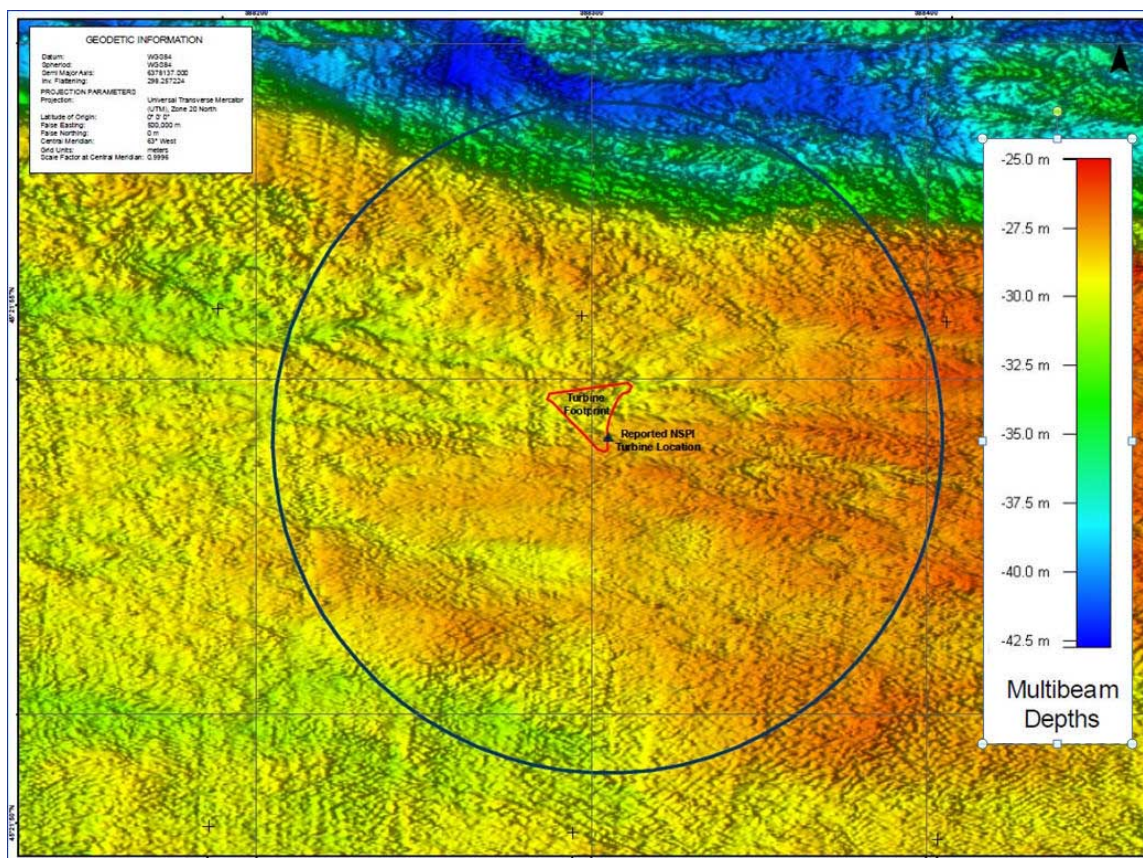
Figure 6 A multibeam bathymetric shaded relief map of the NSPI/OH1 site showing the location of the device (red triangle) relative to detailed bathymetry. The multibeam data was collected by Seaforth Geosurveys and is presented at 0.5 m resolution. The CHS reported location for the device is also shown as a small black triangle. The circle is 200 m in diameter centered on the officially reported position.

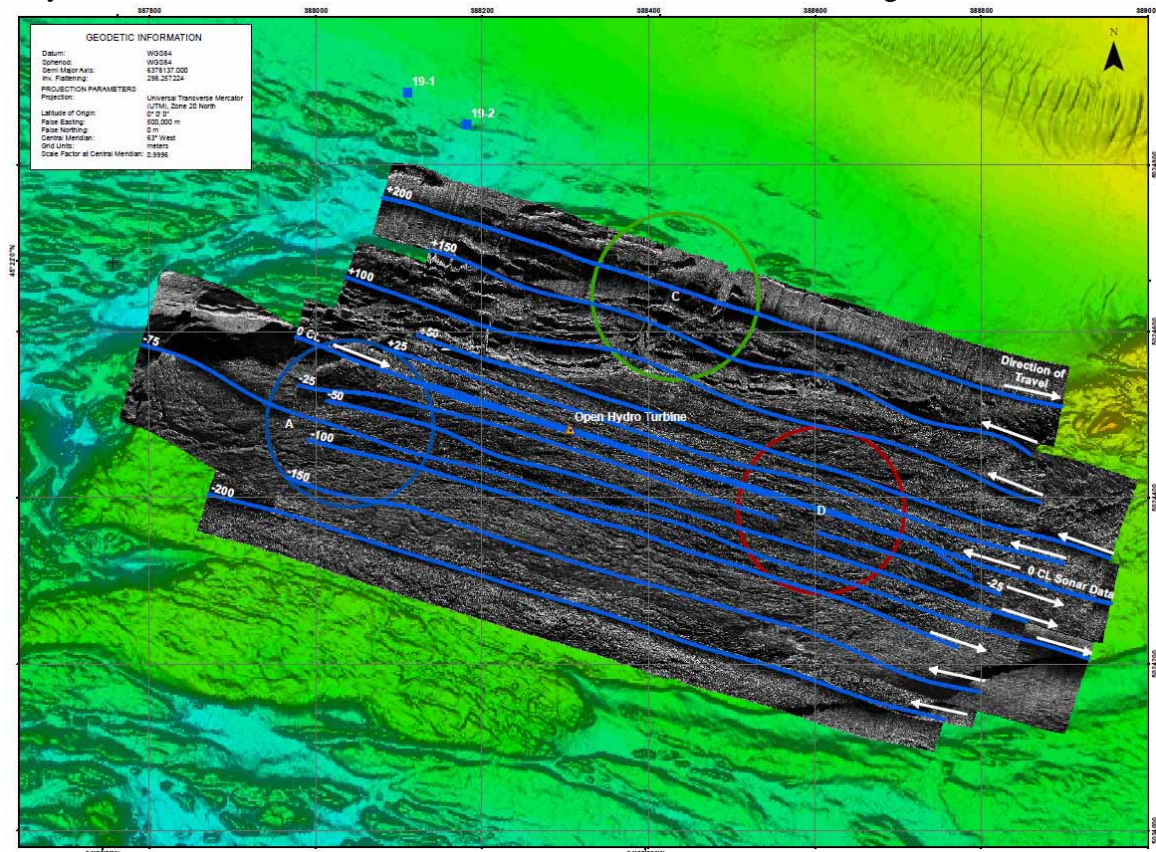
Figure 7 A sidescan sonar mosaic produced from data collected during the monitoring survey. It is superimposed over the multibeam bathymetry (Background). The location of sites A, C, D and NSPI/OH1 are shown. Direction of travel of the sidescan tow fish is shown by arrows.

A sidescan sonar survey (Seaforth Geosurveys Inc., 2011) was conducted for the monitoring study over and around the device and a mosaic has been constructed (Figure 7). The sidescan information was draped over the multibeam bathymetry and was in good agreement with the location of the major morphological features on the seabed. However, to maximise an understanding of the effects of the device, in particular the feet, it was necessary to precisely locate their positions on the sidescan sonograms. This was a difficult process brought about by the strong currents and limits of sidescan surveying that produces distortion of features. The sidescan data was of high quality with few artifacts and this allowed for a direct overlay and comparison with the multibeam information and the location of the device. Through rubber sheeting methods and landmark identification, it was possible to adjust the sonograms in the GIS for direct correlation. This facilitated the accurate plotting of the locations of the device feet on the raw sidescan sonograms (Figure 8). The original sonograms are the highest resolution imagery from the survey. It is considered that they have been plotted with ± 1 m

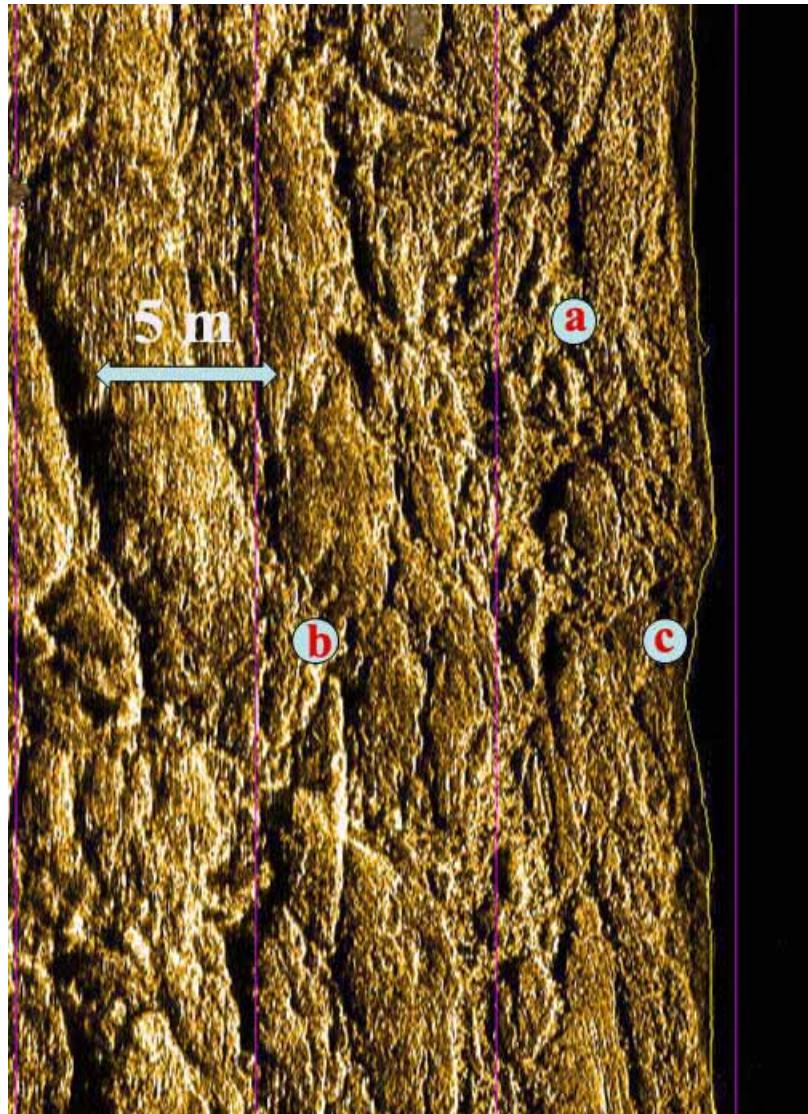
Figure 8 Line -25 sidescan sonogram from the monitoring survey over site NSPI/OH1. The interpreted position of each of the device feet is indicated.

The sidescan sonar image that best depicts the seabed and the position of the device feet is line -25 (Figure 25 and 8). It shows the seabed as a series of hummocky broad ridges and smaller isolated linear ridges. Sidescan information shows both seabed hardness and relief. Shadows from objects are differentiated from depressions by the presence of high backscatter (light tone) followed by dark regions (shadows). Depressions are represented by a shift to dark tone without a sonar facing region of high backscatter. Of particular note is that two feet appear to coincide with small depressions on the seabed (Figure 25). Given that the major part of the area around the device is flat, this suggests that it may have shifted to self locate the feet in slightly deeper areas for greater stability. A close inspection of the sidescan sonogram shows that at least two of the feet (A and B) may have eroded small depressions in the volcanic bedrock (Figure 25). If this occurred, the device may have sunk downward approximately 1 m until a flange on the base of the feet was reached and a more stable position was achieved. An examination of device tilt information and abrasion marks on the feet post recovery should provide information on such a hypothesis.

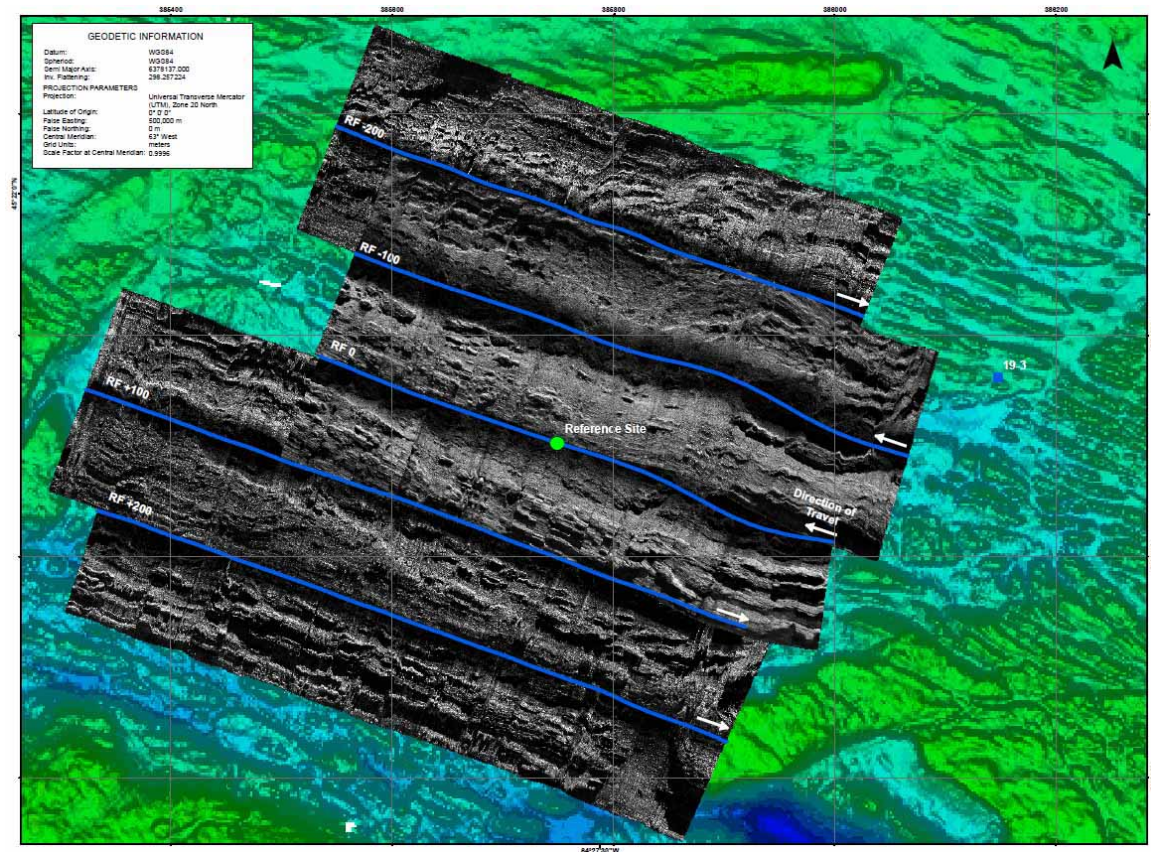
Figure 9 A sidescan sonar mosaic from the Reference Site overlying multibeam bathymetry. The Reference Site occurs in the centre of the mosaic (green dot). Survey lines and direction of travel are indicated.

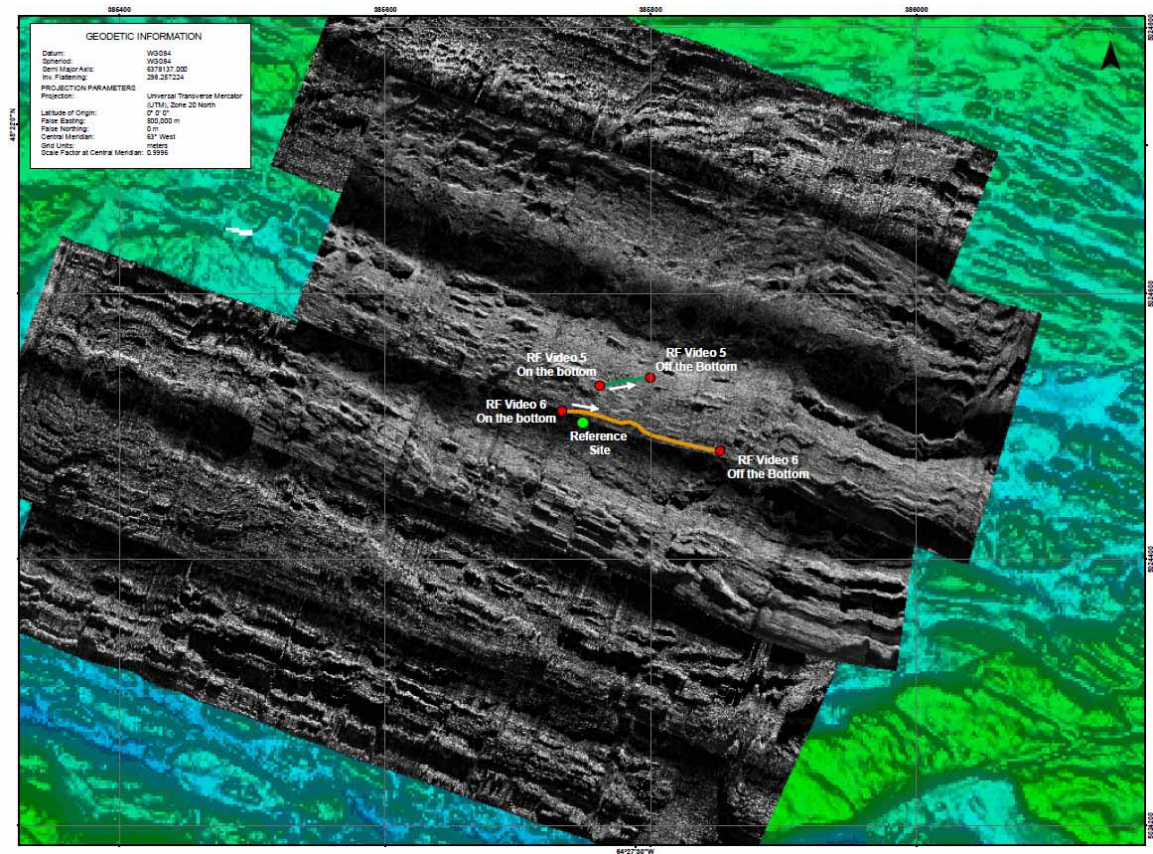
Figure 10 Sidescan sonar mosaic of the Reference Site showing the tracks of the towed video system and the reference site.

Bottom towed video cameras were towed across both the RS and the NSPI/OH1 and the track plots are shown in Figure 10 and 11. The data is of moderate quality and the speed of the camera moving across the seabed and particulates in the water column have reduced visibility. The camera varies in height above the seabed during the tows and where it is near the seabed it provide definition of boulders and cobbles, their shape, biogenic growth and the presence of exposed bedrock. The video imagery was compared with the sidescan sonograms and previously collected multibeam bathymetry to assess seabed change.

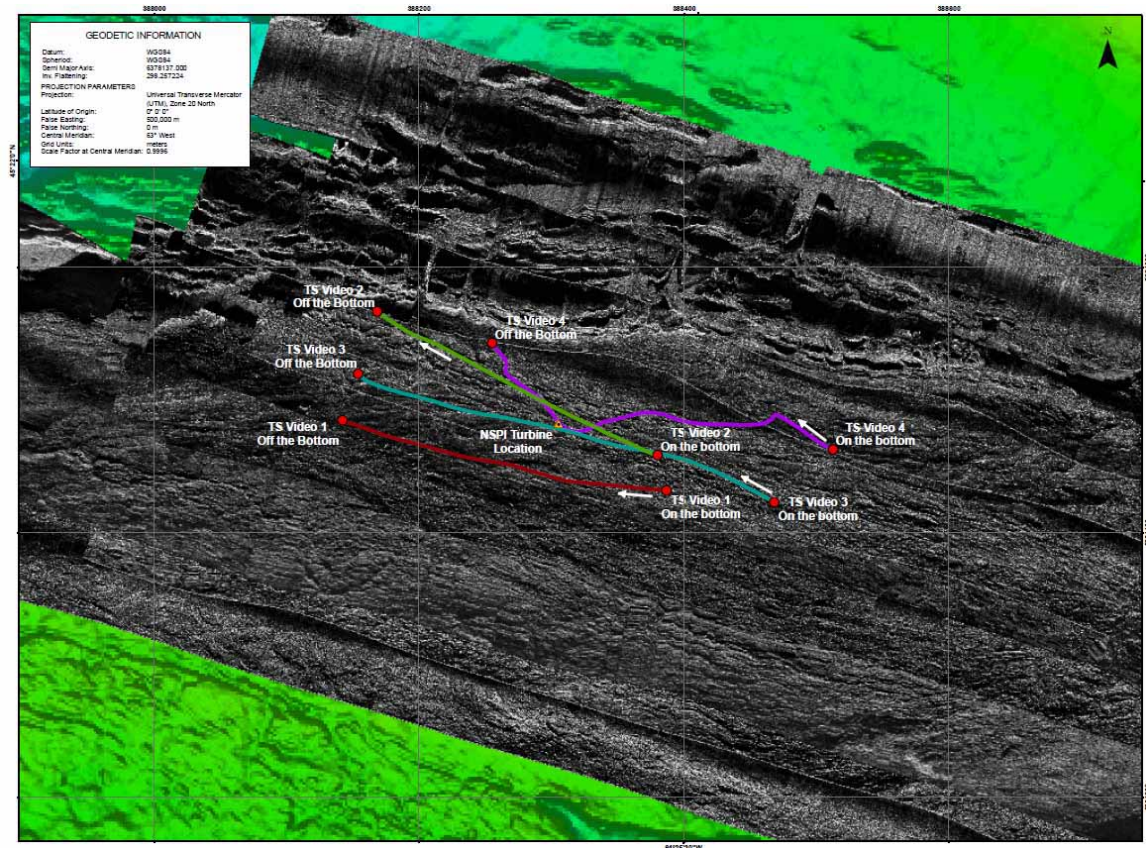
Figure 11 Sidescan sonar mosaic of NSPI/OH1 site showing the tracks of the video transects. The background is a multibeam bathymetric image.

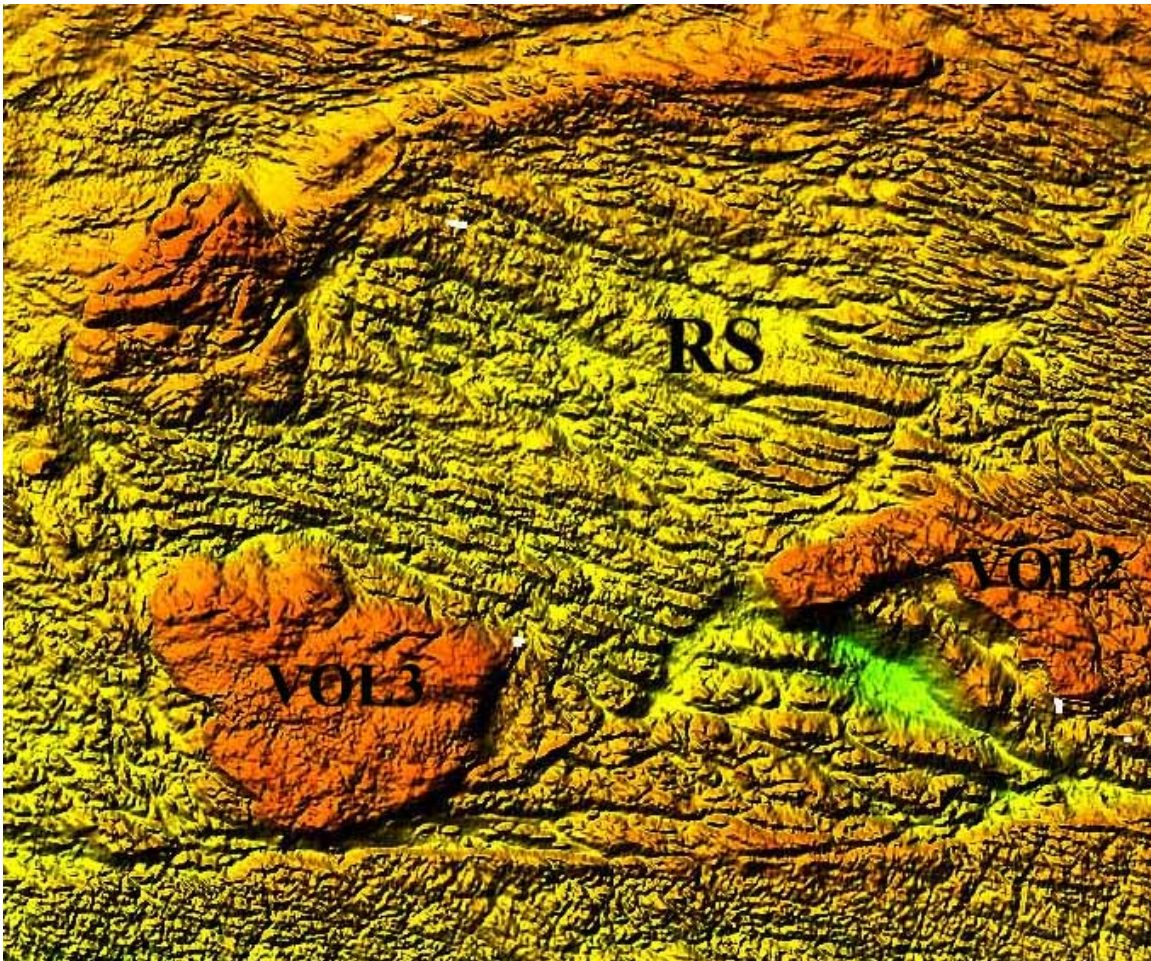
Figure 12 A multibeam bathymetric, shaded relief, colour depth-coded map of the Reference Site with the volcanic platforms identified as VOL2 and VOL3.

The reference site lies 1.4 km to the west of the western edge of the CLA at lat and long and in 54 m water depth. Figure 12 is a multibeam bathymetric image at 2 m resolution from the region of the RS and Figure 13 is a contoured bathymetric map from the same area, contoured at 2 m intervals. The region of RS has never been described in detail. No bottom photographs or video have been collected from this site but it was the first site chosen for a current meter deployment and that information has been collected, processed and presented in earlier reports.

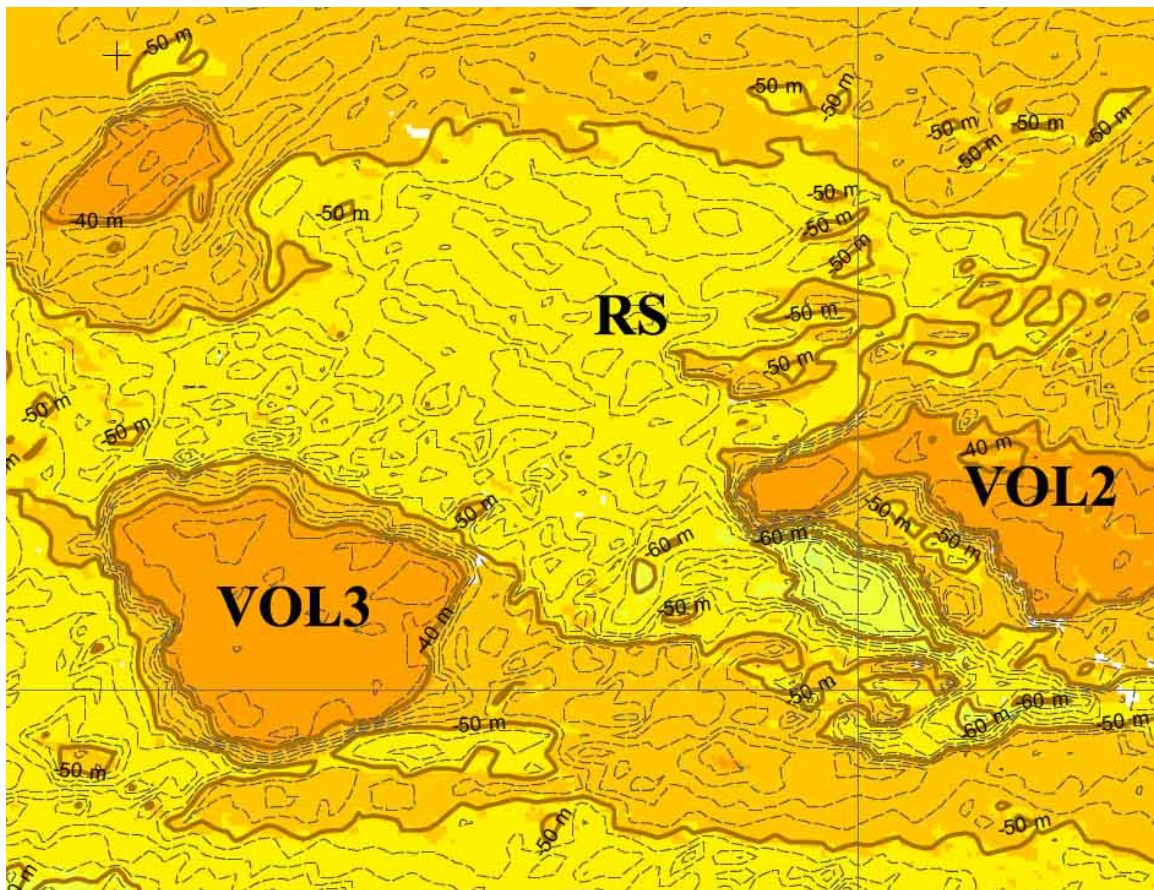
Figure 13 A contoured bathymetric colour-coded and contoured map of the Reference Site. Contour intervals are 2 m.

RS lies in a slight depression surrounded in the southwest by the high of VOL3, in the southeast by the high of VOL4, and in the north by a shallower ridge trending northeast. The multibeam bathymetric image of Figure 12 shows that RS occurs in a region of southeast trending ridges interpreted to represent outcrops of bedrock with deeper flatter and linear troughs between ridges. Here the bedrock consists of Carboniferous sandstone, siltstone and mudstone. The beds dip to the northeast with the steepest flanks to the southwest as portrayed as shadows on the multibeam bathymetry. The multibeam bathymetry shows that the region around RS is flatter and smoother indicating a cover of surficial sediments. The flatter regions show up more clearly on the slope imagery extracted from the multibeam bathymetric data (Figure 14). The slope imagery shows the steepness of the seabed in dark tone with flat regions showing as light tone. Some of the flat regions can also represent exposures of bedrock. Figure 15 is a low resolution backscatter image of the region that represents a proxy for seabed hardness where dark tone is bedrock and gravel, and light tone sand and mud. The image shows RS as dark tone, therefore, a hard seabed of exposed bedrock or gravel. Linear light tone regions of this image are artefacts of data processing over steep slopes. The backscatter

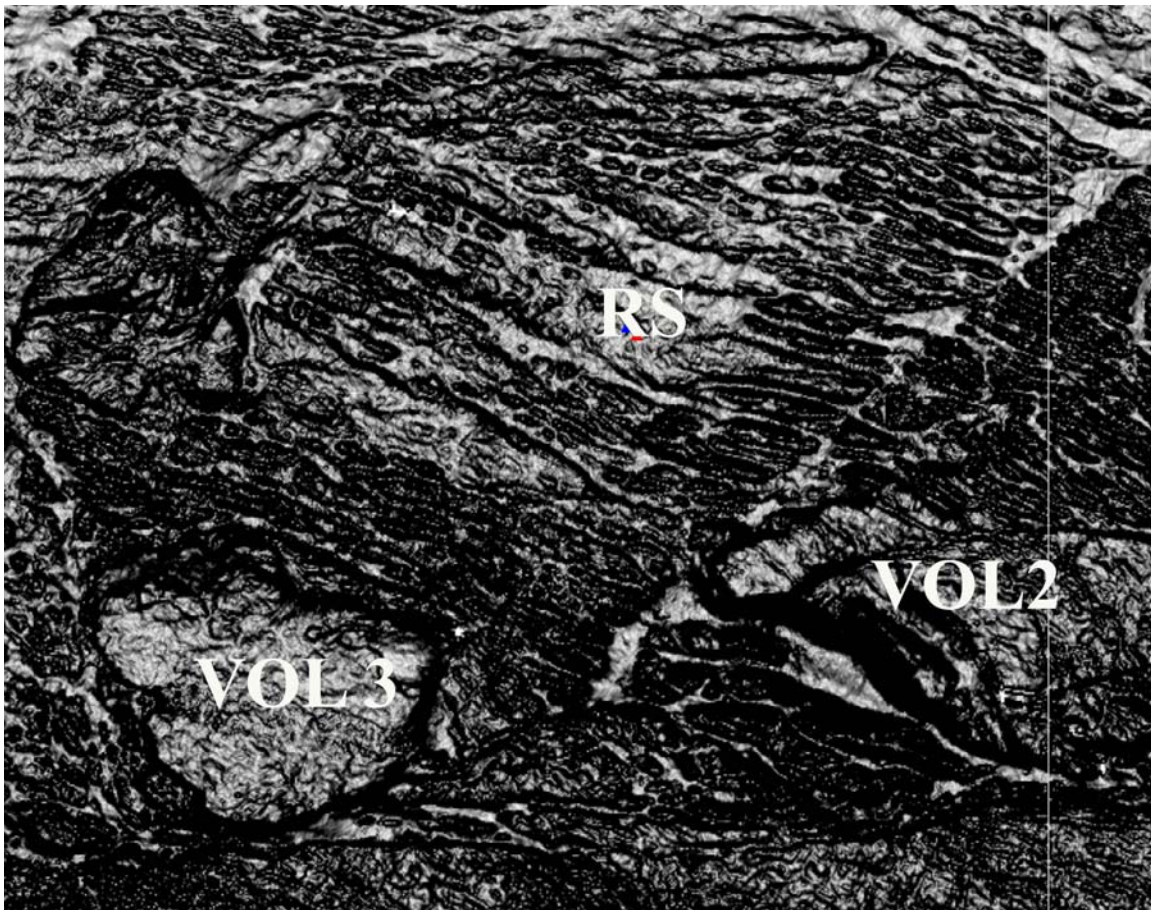
Figure 14 A slope map of the Reference Site produced from the multibeam bathymetric data. Flat areas are light toned and steep areas are dark toned.

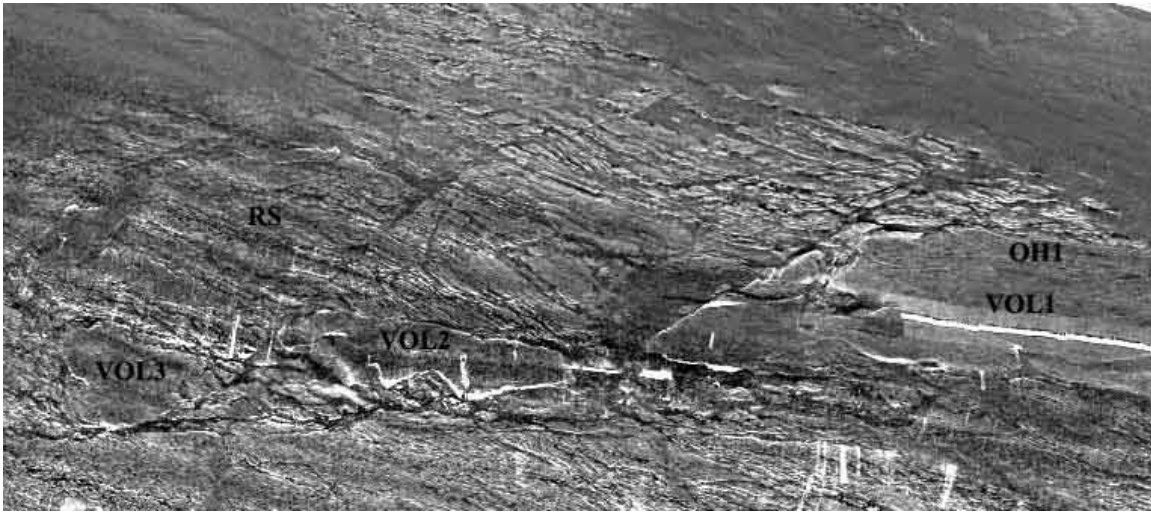
Figure 15 A regional backscatter image of the sites NSPI/OH1 and RS showing that they occur over a very hard seabed of gravel and bedrock. Volcanic ridge segments 1 -3 are identified for reference.

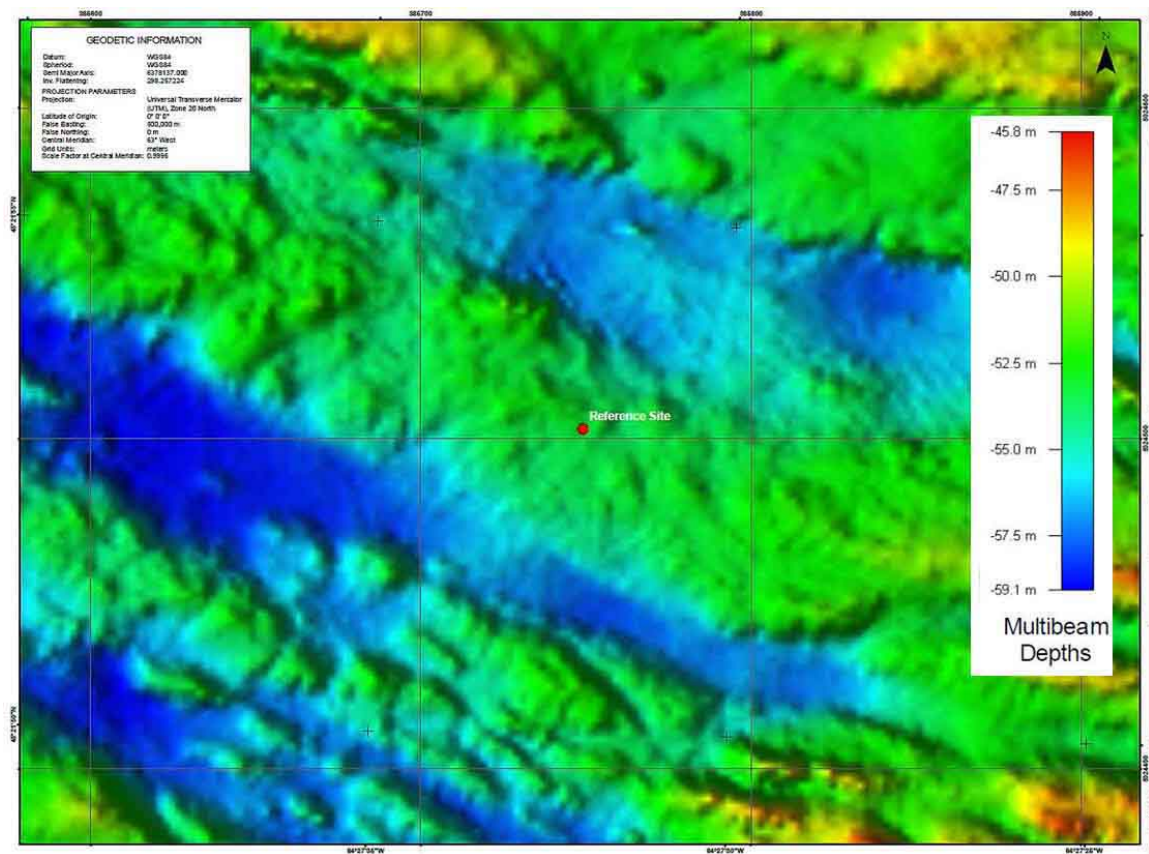
Figure 16 A high resolution multibeam bathymetric image of the Reference Site based on the 2 m resolution survey. It lies on a hummocky seabed of a broad ridge trending southeast.

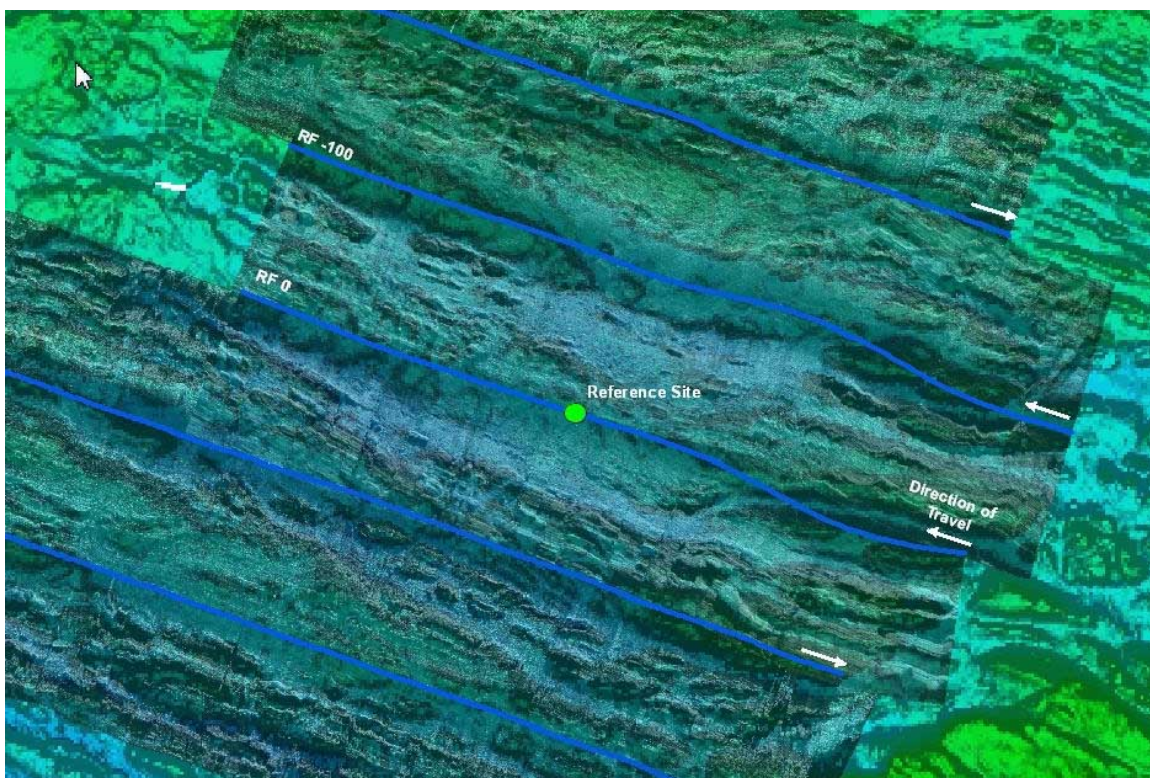
Figure 17 A sidescan mosaic from the Reference Site, screened at 50% transparency to allow for direct comparison with the underlying multibeam bathymetry.

The monitoring survey of the RS consisted of a sidescan sonar survey, the construction of a sidescan mosaic (Figure 17) and the collection of towed video imagery across the site. The sidescan data were draped over the multibeam bathymetry to determine if the seabed has changed over the 5 years since the multibeam bathymetry was collected. A series of screened mosaics were prepared at varying transparencies to aid in this assessment (Figure 17, 18).

The RS is located near the centre of the sidescan mosaic. The survey lines were run parallel to the bedrock structure in a northwest direction. The mosaic shows that the RS is located in a broad region of sediments overlying bedrock. Although many bedrock ridges crop out on the seabed, they represent approximately 30% of the seabed area. The sidescan imagery show considerably more detail about seabed sediments and bedrock than the multibeam bathymetry. The sidescan has a resolution of 20 cm as compared to the 2 m resolution of the multibeam bathymetry for this site.

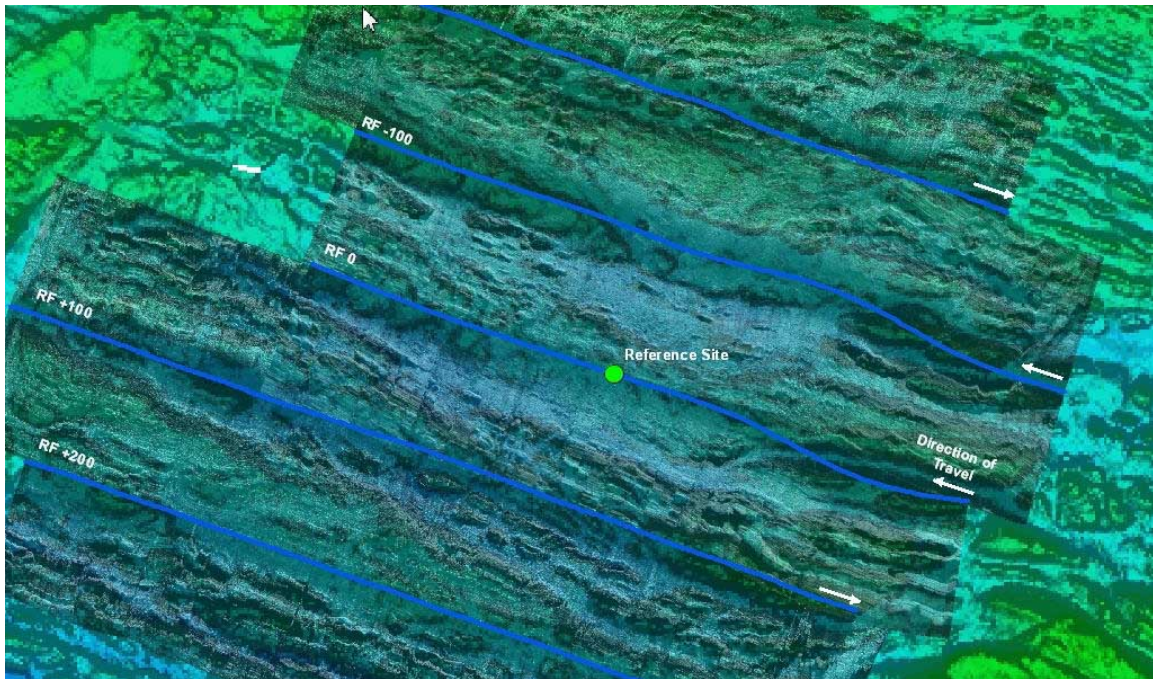
Figure 18 A sidescan mosaic from the Reference Site, screened at 20% transparency to allow for direct comparison with the multibeam bathymetry.

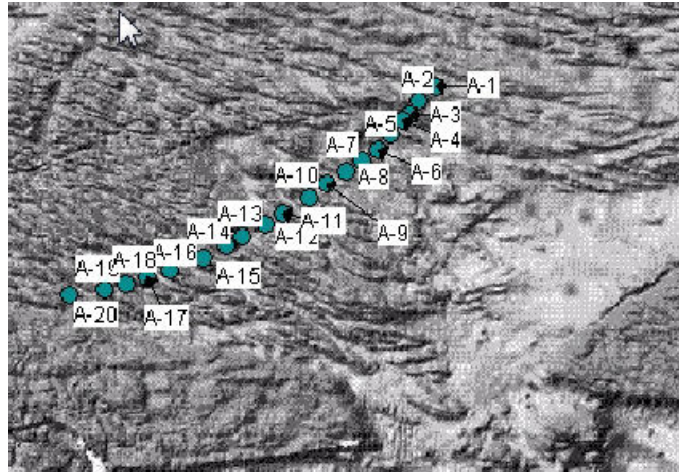
Figure 19 A map of the positions for the closest bottom photographs A1 – A20 to the Reference Site. The RS lies to the west of these locations.

Video or bottom photographs had not been collected at the RS before the monitoring study. The closest existing bottom photographs were from sites A1 to A20 to the east north of VOL2 (Figure 19) and they were taken over a similar seabed character as defined by the multibeam bathymetry and sidescan data. Figure 20 is a selection of bottom photographs from those sites that show a seabed mostly composed of gravel with boulders and exposed bedrock. Between the boulders granules, pebbles and cobbles are present. Large boulders and bedrock have biogenic growth covering their surfaces. These photographs are contained in a report by EnviroSphere Consulting to FORCE. Examination of the video transects 5 and 6 across RS shows the seabed dominated by rounded boulders with occasional bedrock outcrop. Pebbles and cobbles lie at the base of the boulders. The large boulders and bedrock outcrop are covered with breadcrumb sponge and other benthic encrusting organisms.

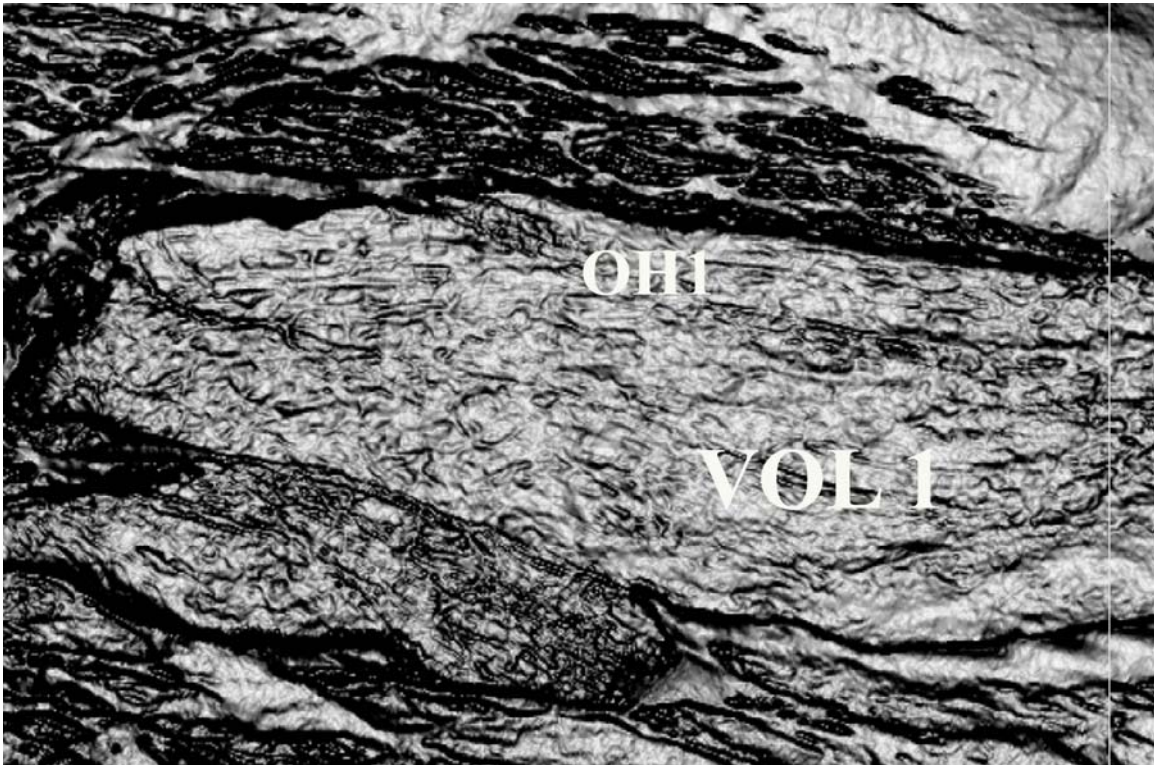
Figure 21 A slope map of the NSPI/OH1 site on Volcanic Platform 1. The seabed is uniform and flat in this region.
