FUNDY TIDAL ENERGY DEMONSTRATION PROJECT
Environmental Effects Monitoring Report

Side Scan Sonar Survey Final Monitoring Report

**Environmental Monitoring of Seabed Sediment Stability,
Transport and Benthic Habitat at the Reference Site and
the Vicinity of the NSPI TISEC Location
in the Minas Passage**

March 17 /2011

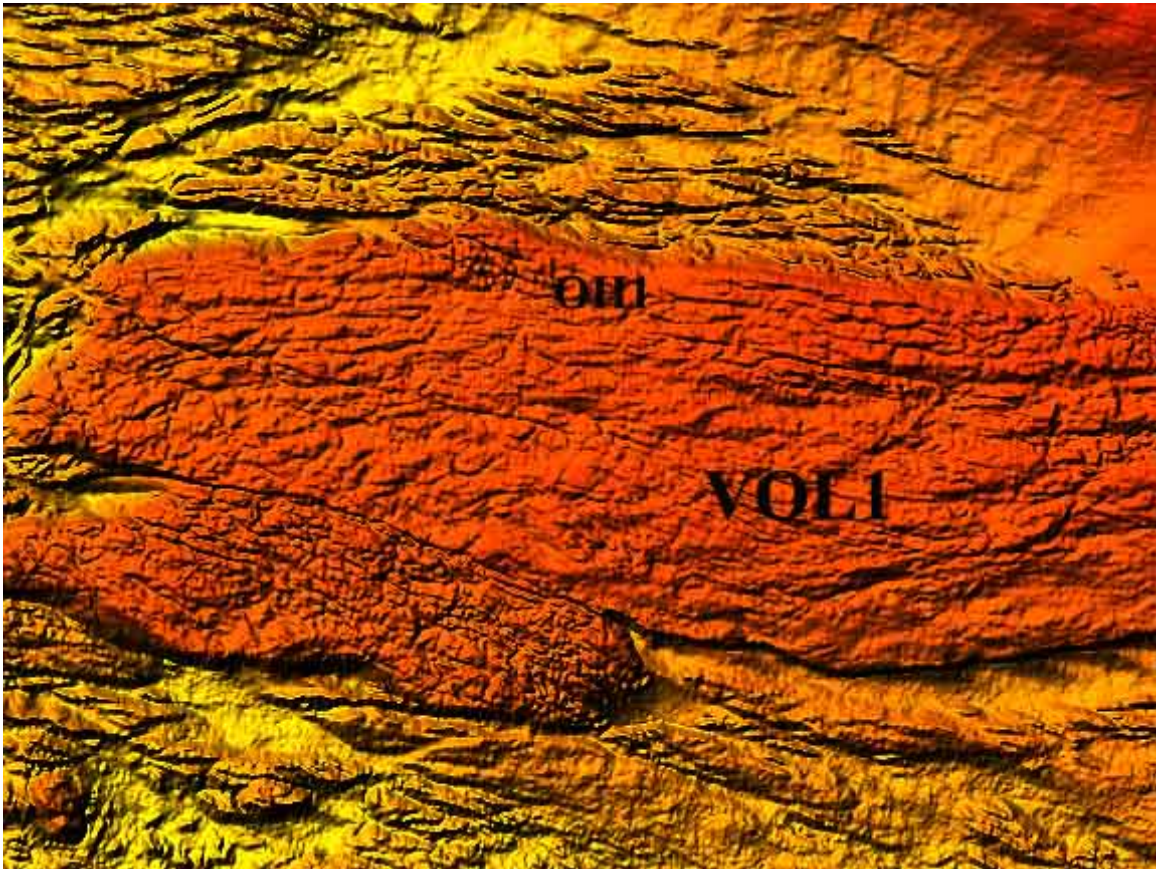
Figure 22 A 2 m resolution multibeam bathymetric map of NSPI/OH1 showing its location on the volcanic platform VOL1. Directly to the west of the site the seabed is rougher and more ridged.

The NSPI/OH1 test installation position lies on the northern part of the volcanic platform that extends to the west from Black Rock (Figure 2 and 3). The site lies to the east of Site A and southwest of site C. It lies 255 m west of the centre of site A in 28.5 m water depth. The 2 m resolution multibeam bathymetric data (Figure 22) shows that the location occurs to the east of a linear and rough region of the volcanic platform. A contoured map of bathymetry (Figure 23) shows that the region lies in water depths slightly below 30 m water depth and that this part of the volcanic platform is relatively flat and broad with water depths between 30 and 28 m (contour interval 2 m). The backscatter imagery (Figure 15) shows that NSPI/OH1 lies in a region of homogeneous dark tone – suggesting a hard and consistent seabed. The backscatter imagery has been processed at low resolution of less than 5 m, so backscatter details of the setting cannot be determined. The slope imagery (Figure 21) shows the location in a region of low slope with minor ridging and isolated flat circular areas.

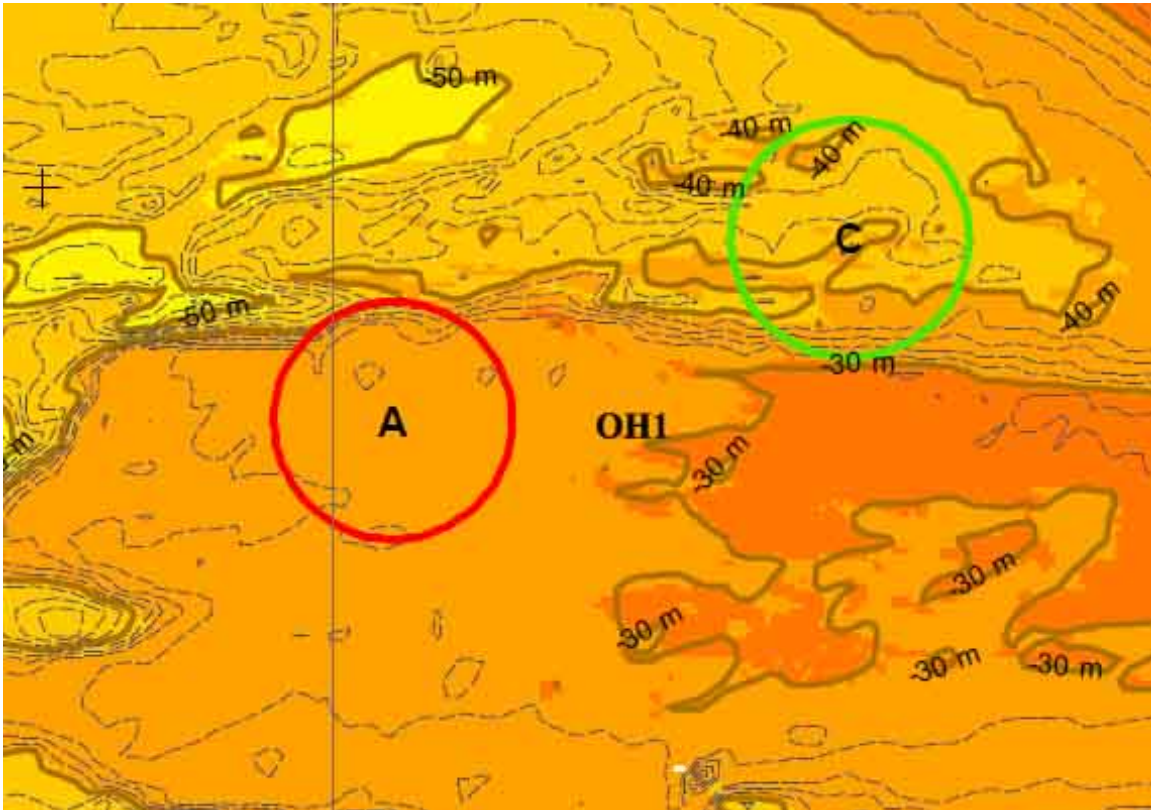
Figure 23 A bathymetric contoured map of the site of NSPI/OH1, site A and site C. The contour interval is 2m and shows that the volcanic platform is quite flat.

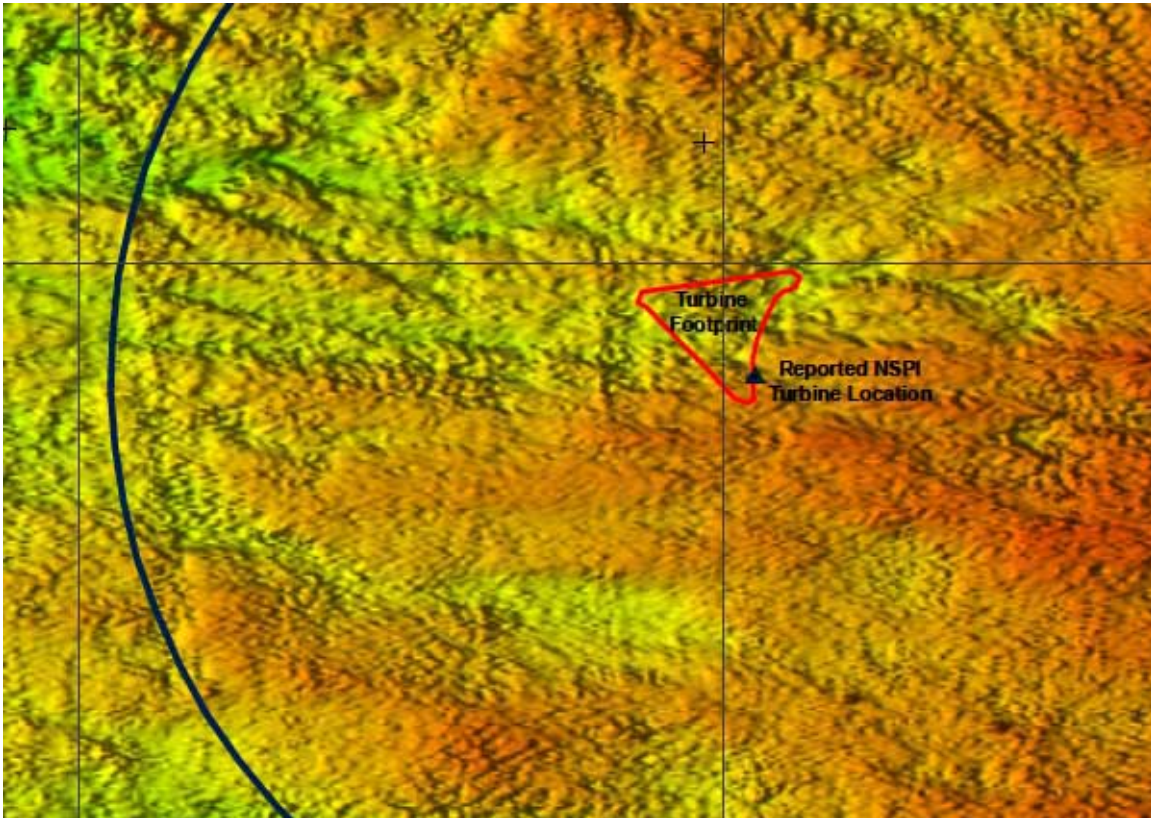
Figure 24 A high resolution multibeam bathymetric image showing the location of the NSPI/OH1 site on the seabed and the relief of the bottom. From this image the exact location and water depths of the position of the feet can be determined.

Topographic elements of the volcanic platform can clearly be seen and used to control the correlation of the sidescan imagery with the position of the device. Figure 24 is a shaded relief multibeam bathymetric map of the NSPI/OH1 site showing the highest resolution attainable from the 0.5 m resolution survey conducted during initial site selection, with the outline of the gravity base and reported position superimposed.

The NSPI/OH1 device lies on a hummocky and ridged volcanic surface (Figure 24). The multibeam imagery shows that the feet occur in different water depths indicating that the structure was tilted slightly to the north. The western front foot is in -29.2 m, the south back foot in -28.3 m and the north back foot in -29.6 m water depths. This shows a difference of 0.9 m across the device. The southern foot lies on a bedrock ridge while the western and northern ones are in slight depressions. For detail on the characteristics of the site it is necessary to examine the raw sidescan sonograms. The sidescan survey passed over the site three times, over the centre, and at -25 and +25 m on either side.

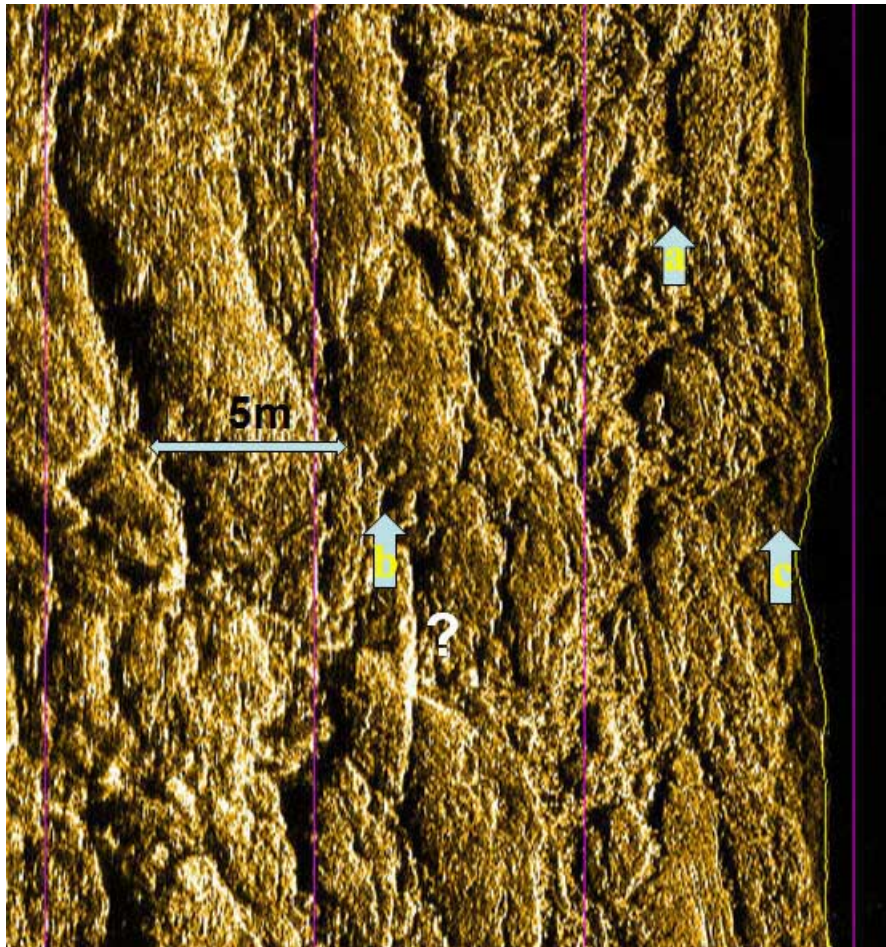
The sidescan sonar image that best depicts the seabed and the position of the device feet is line -25 (Figure 25 and 8). It shows the seabed as a series of hummocky broad ridges and smaller isolated linear ridges. Sidescan information shows both seabed hardness and relief. Shadows from objects are differentiated from depressions by the presence of high backscatter (light tone) followed by dark regions (shadows). Depressions are represented by a shift to dark tone without a sonar facing region of high backscatter. Of particular note is that two feet appear to coincide with small depressions on the seabed (Figure 25). Given that the major part of the area around the device is flat, this suggests that it may have shifted to self locate the feet in slightly deeper areas for greater stability. A close inspection of the sidescan sonogram shows that at least two of the feet (A and B) may have eroded small depressions in the volcanic bedrock (Figure 25). If this occurred, the device may have sunk downward approximately 1 m until a flange on the base of the feet was reached and a more stable position was achieved. An examination of device tilt information and abrasion marks on the feet post recovery should provide information on such a hypothesis.

Figure 25 A sidescan sonogram of the site of NSPI/OH1 showing the position of the feet on the seabed. Arrows are used to indicate the locations and not obscure the actual positions. Note the linear unusual feature near the foot b noted with ?.

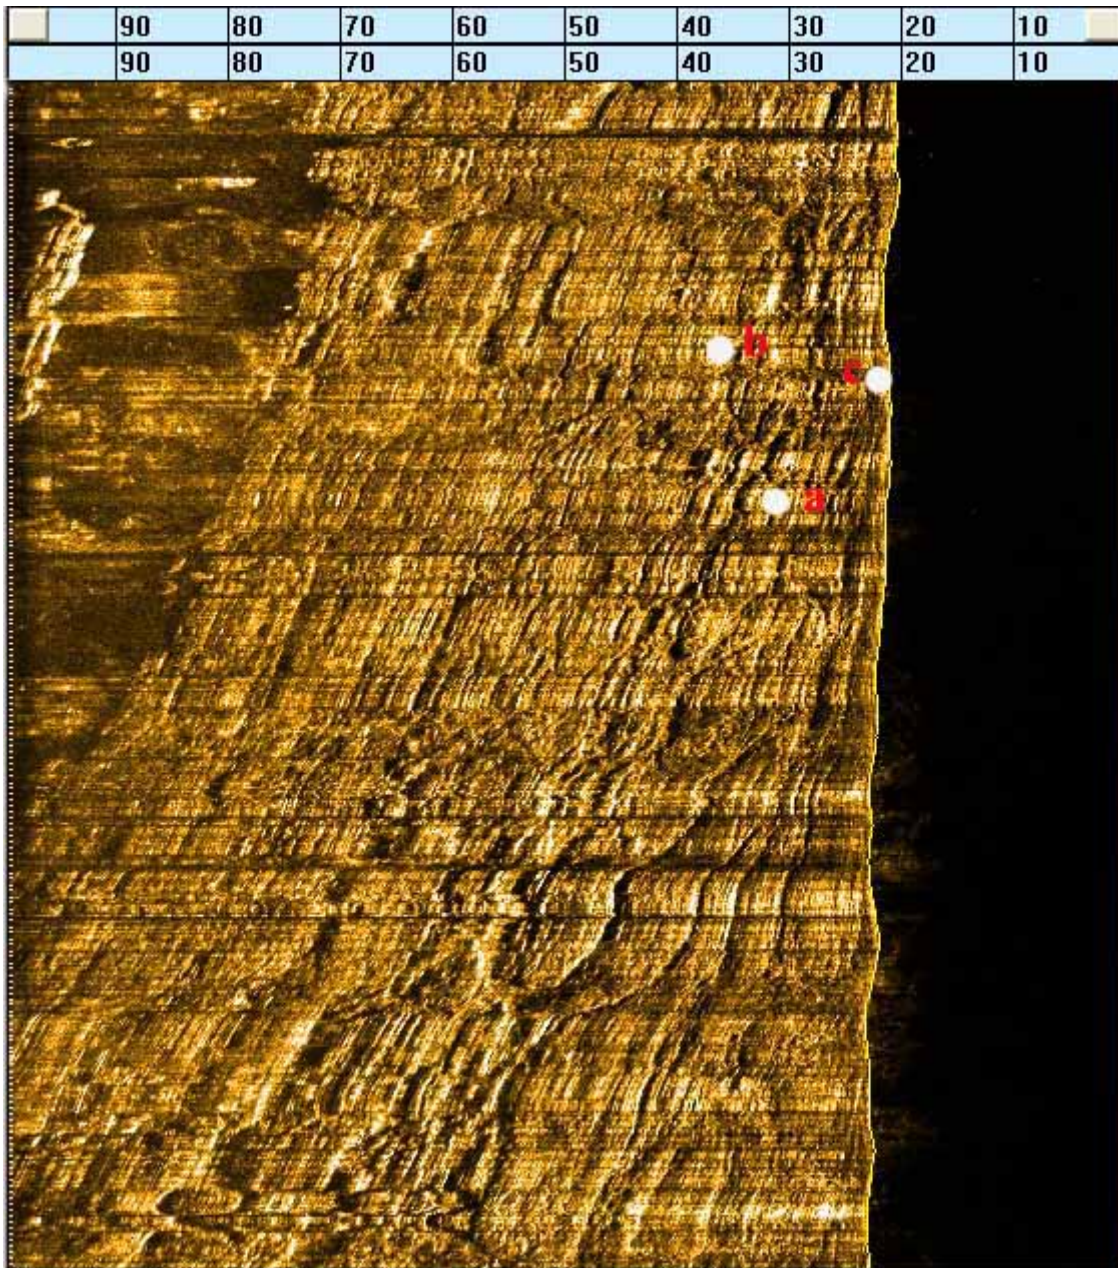
Figure 26 is the pre deployment sidescan sonogram from the same region that was collected during the first survey of the area to choose the sites in 2008. The tow fish was

subjected to severe motion by the currents and turbulence during that survey and this presents the information with distortion. A direct comparison of the two surveys identifies some larger common features of the site but details as provided by the sonograms of the monitoring survey cannot be seen. This limits the ability to assess change at the seabed caused by the turbine.

Figure 26 A sidescan sonogram from the site of NSPI/OH1 collected in 2008. It has been compared with the sonograms collected for the monitoring survey to detect change. However, the quality of the first survey data was less because of excessive fish motion due to strong currents and turbulence that was not present during the monitoring survey. The locations of the three feet of the gravity structure are indicated.
