Appendix 4:
Benthic Communities
(Envirosphere 2009a)

Seabed Biological Communities in the Minas Passage

*Minas Basin Pulp and Power Limited
Hantsport, Nova Scotia*

*Envirosphere Consultants Limited
Windsor, Nova Scotia*

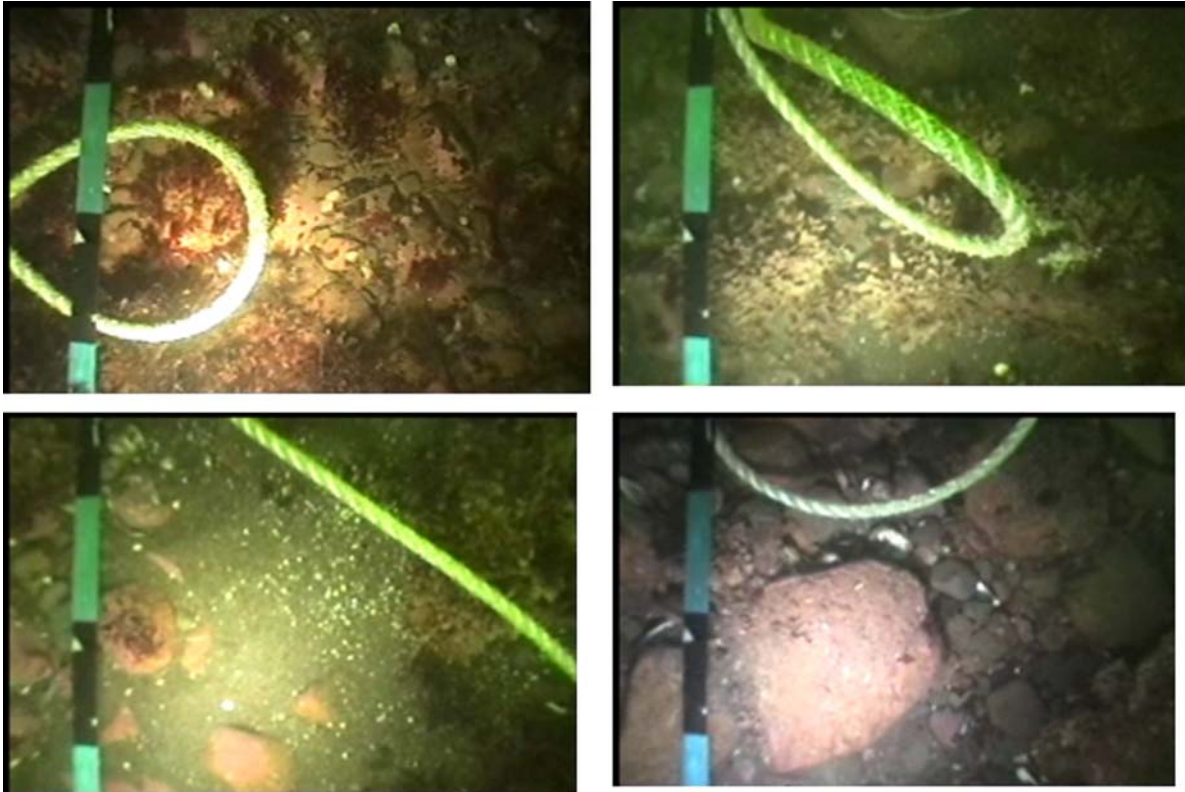
Figure 8. Cobble substrate on upper slope of nearshore shelf with *Fucus* sp, *Palmaria* sp, coralline algae, *Flustra* sp, and barnacles.

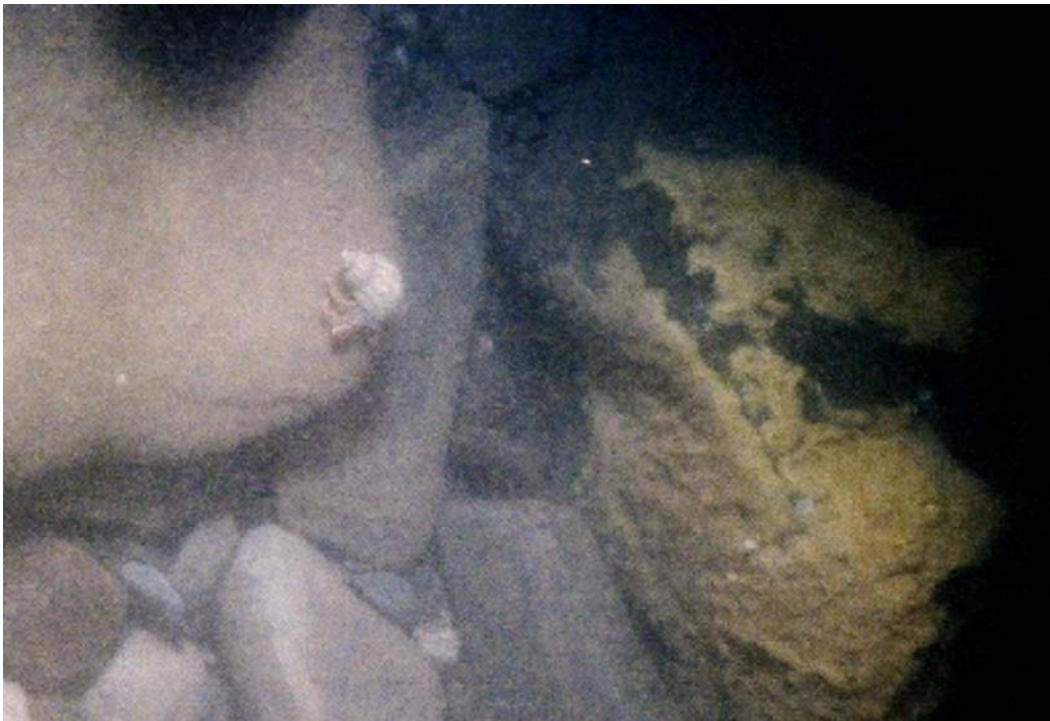
Figure 9. Hermit crab and *Halichondria* sp sponge in Cobble and Boulder seabed zone.

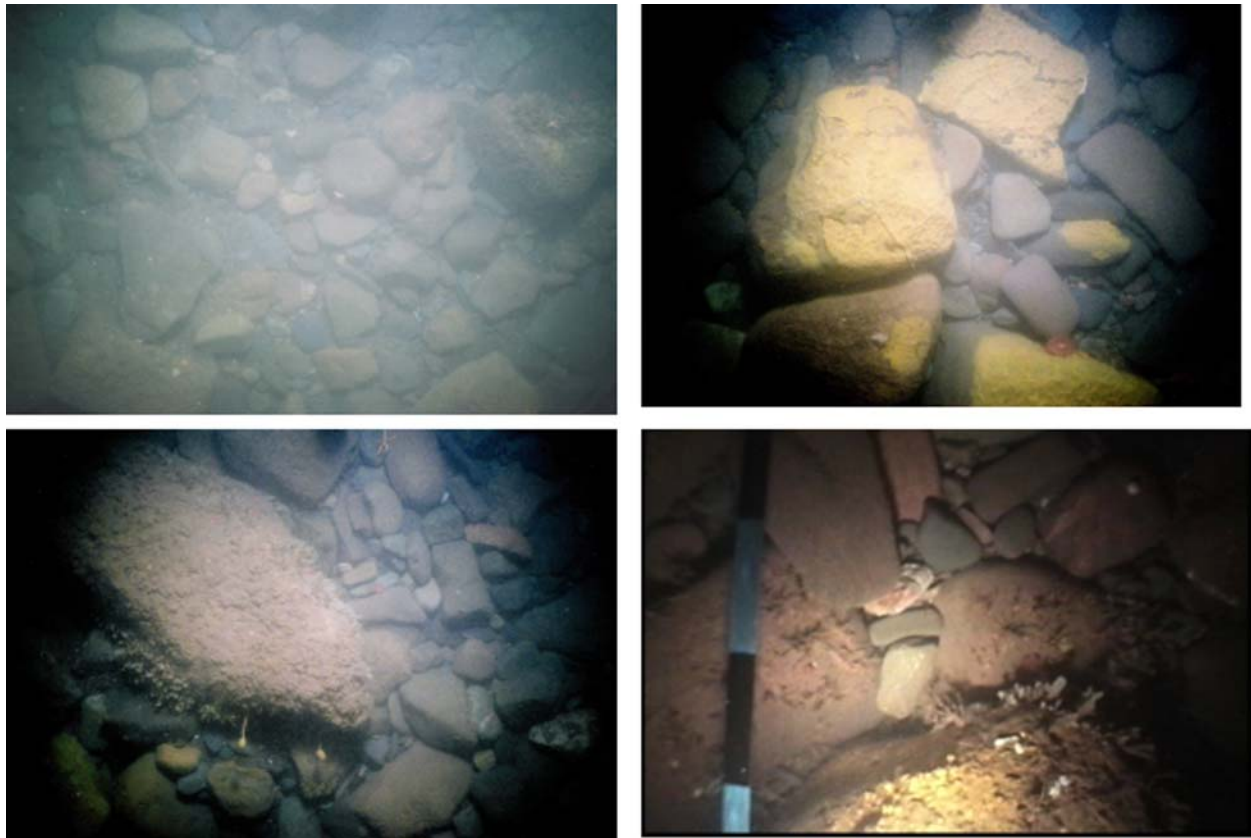
Figure 10. Examples of biological community, Cobble and Boulder seabed zone. Upper left, clean cobbles and boulders with occasional encrusting sponges and hermit crabs. Upper Right, encrusting yellow *Halichondria* sp sponge on boulders showing bedload scour effects around margins, hermit crab and red sea anemone (*Stomphia* sp). Lower Left, boulder with 'biolayer' and 'edge fauna' including the bryozoan *Flustra* sp and two stalked ascidians, *Boltenia ovifera*. Lower Right, *Halichondria* sponge and *Flustra*. Scale units 10 cm.

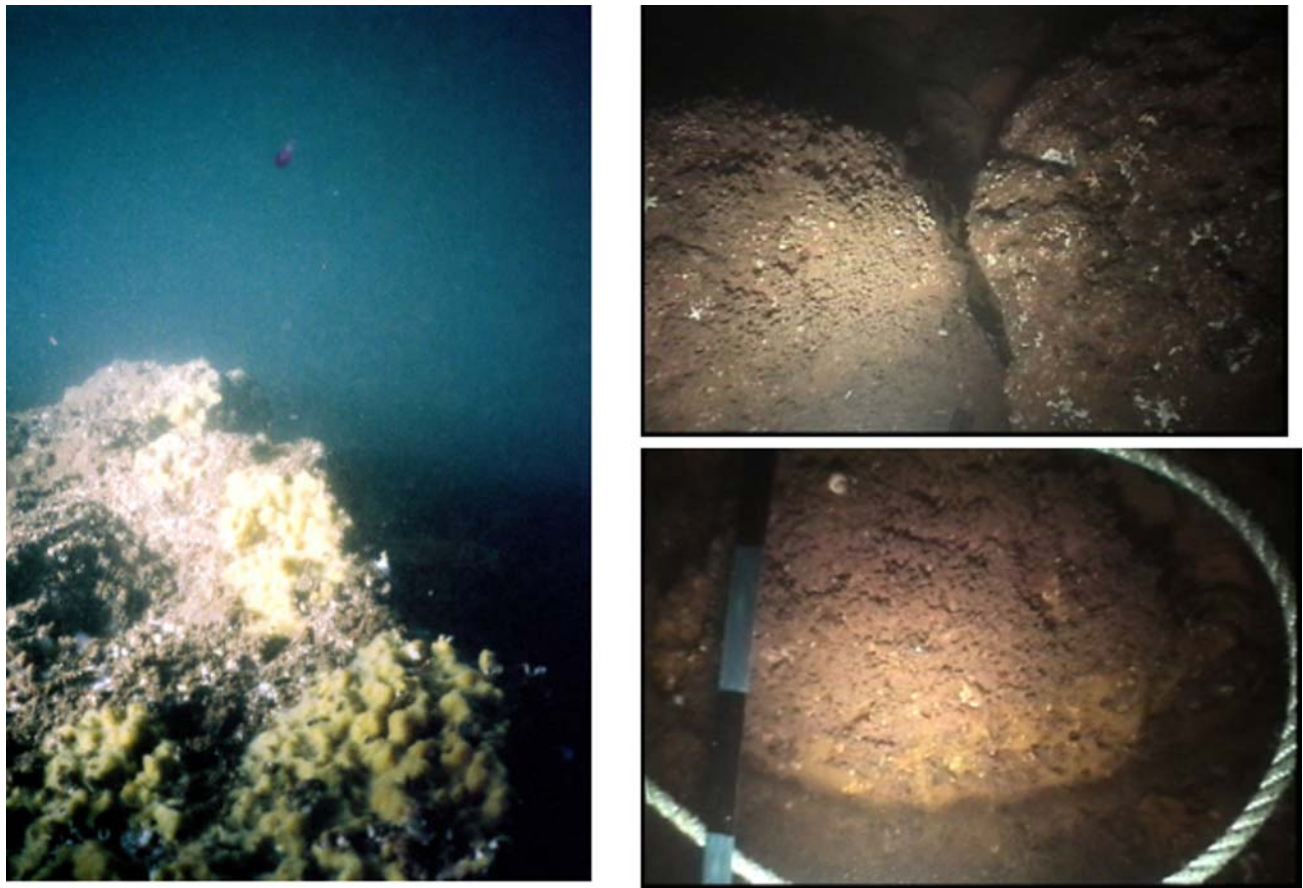
Figure 11. Biological communities on sedimentary bedrock ridges. Left, Breadcrumb Sponge and barnacles on a bedrock prominence. Upper Right, bedrock with 'biolayer' of surface dwelling, tube-building organisms, barnacles, and 'edge fauna'. Lower Right, continuous surface biolayer and a hermit crab on a sandstone boulder.

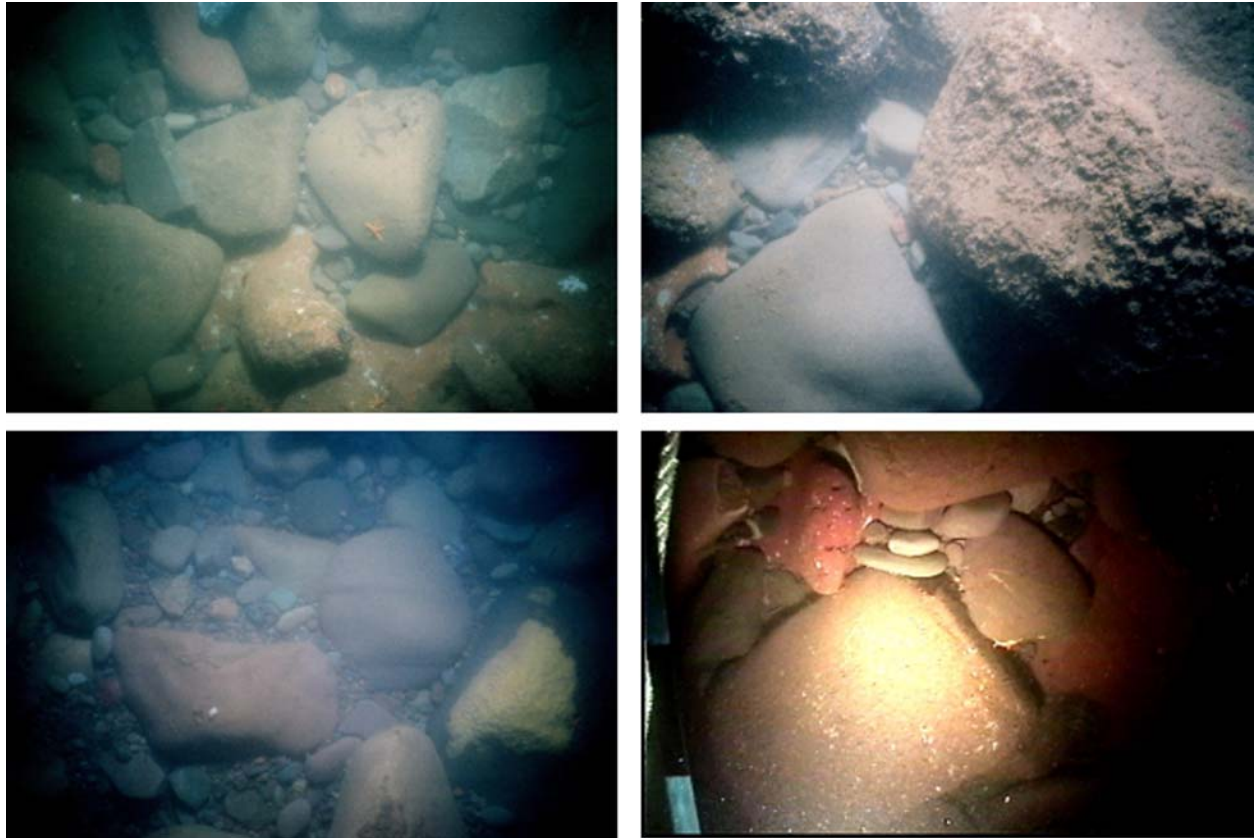
Figure 13. Biological communities of troughs between sedimentary bedrock ridges. Upper left, mostly clean, boulders and cobble with blood star, *Henricia sanguinolenta*, sandstone cobble with 'biolayer' and other organisms. A red mudstone table is uncovered in the lower right corner of the photo. Upper Right, sandstone boulder with biolayer of surface dwelling, tube-building organisms amid smooth cobbles of other types. Lower left, boulders embedded in cobble, one with yellow sponge (*Halichondria* sp) and clean zone at base, believed to be indicative of bedload scour, and one with hermit crab. Lower Right, clean cobble and boulder, including two mudstone cobbles with burrows of boring clams.

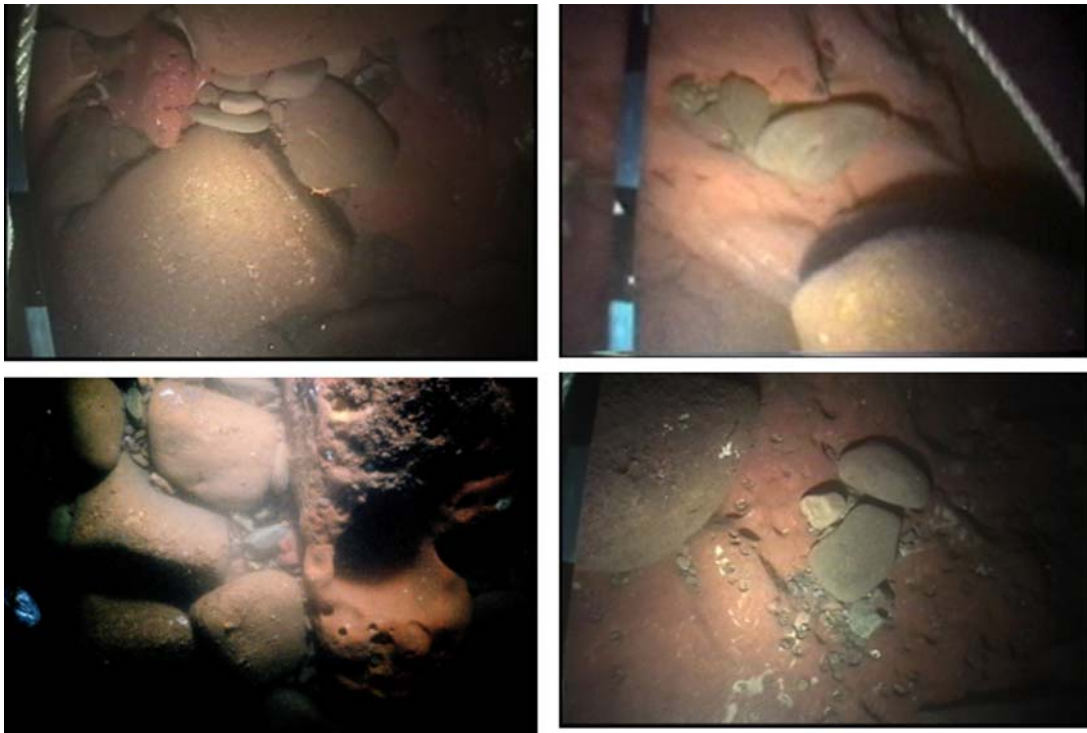
Figure 14. Occurrences of mudstone with holes possibly indicating the present or past occurrence boring clams. The holes have also been suggested to be fossil roots.

Also in the sedimentary troughs, red mudstones frequently show evidence of pits reminiscent of holes bored by boring clams, although there is an alternate geological interpretation that these are fossil root casts. Several species of boring clams are known from Minas Basin in similar rock types in shallow water. One of the only fish seen in the survey, Longhorn sculpin, *Myoxocephalus octodecemspinosus*, occurred in the sedimentary bedrock zone (Figure 15).

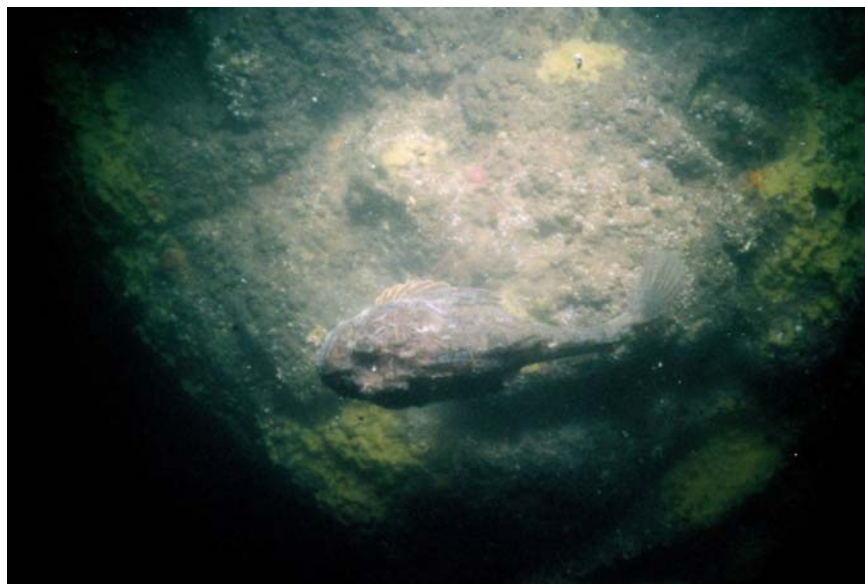
Figure 15. Longhorn sculpin over sedimentary bedrock ridge. Ridge shows a red anemone, *Stomphia* sp., several encrusting sponges, including Breadcrumb Sponge, a blood star *Henricia sanguinolenta*, baracles and a surface biolayer.

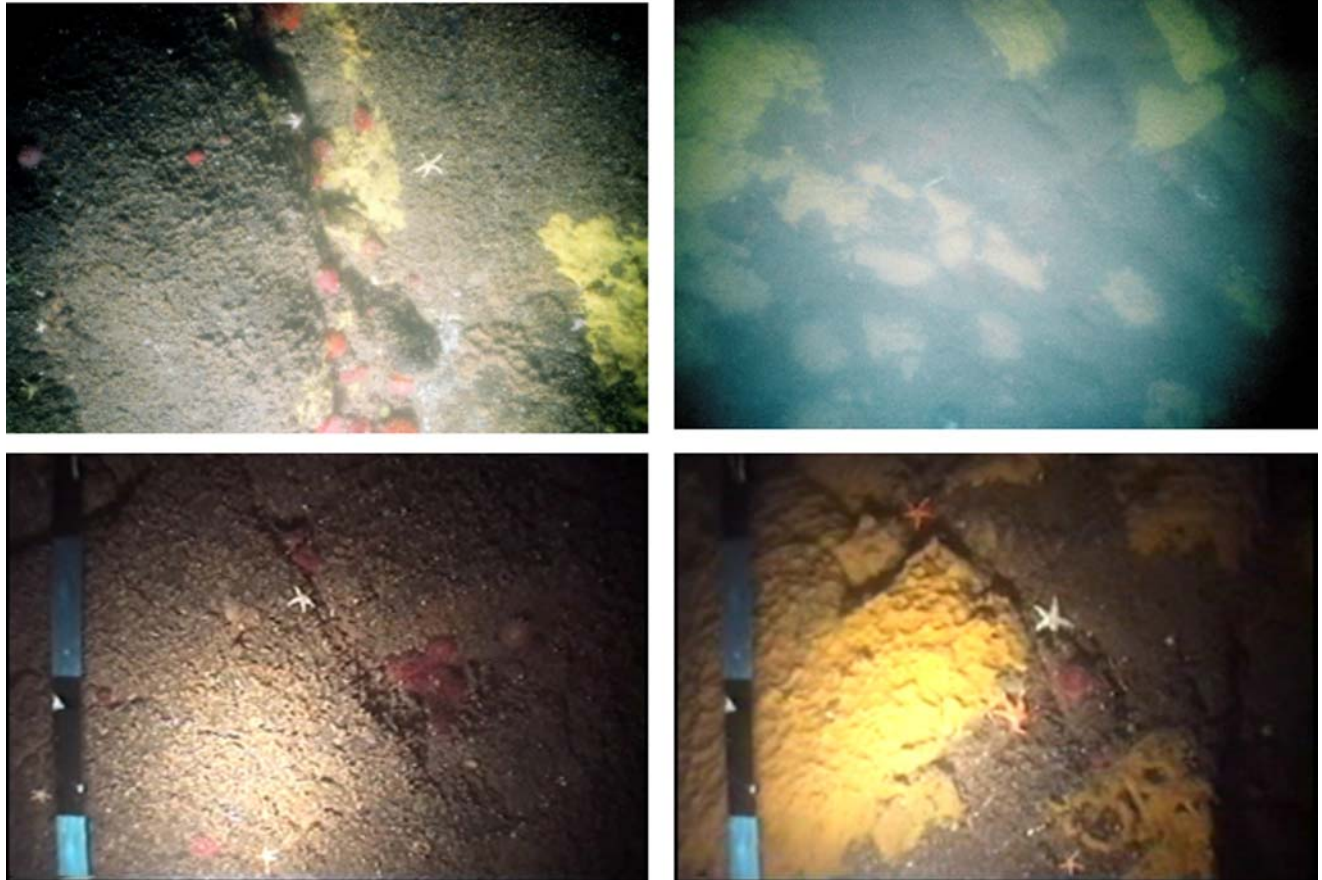
Figure 16. Biological communities of volcanic bedrock platform. Upper Left, 'biolayer' type, which occurs on volcanic bedrock, sea anemones (*Stomphia sp.*), and unidentified seastar. Upper right, distribution of patches of *Halichondria* sponge on flat bedrock surfaces, including red *Stomphia sp.* anemones. Lower Left, biolayer typical of volcanic bedrock, unidentified sponge, and red *Stomphia sp.* anemones. Lower Right, encrusting sponge, volcanic bedrock 'biolayer', red blood stars (*Henricia sanguinolenta*), unidentified seastar, and red *Stomphia* anemone.

Volcanic bedrock platforms (Figure 16-20) display a range of surface characteristics, including level platform like formations with cracks, platforms with boulders strewn over top, as well as irregular rocky crags and surfaces. The surface of the platforms range from about 31 to 34 m.

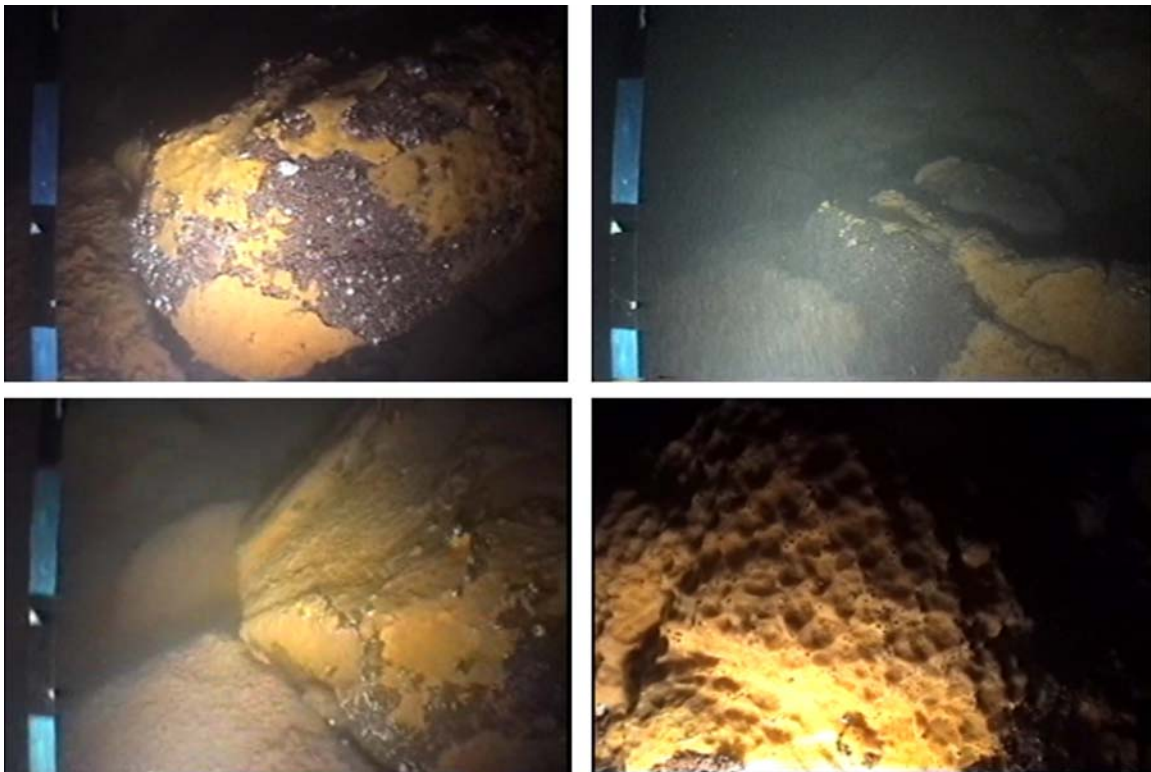
Figure 18. Biological communities on boulders and prominences on volcanic bedrock platform.

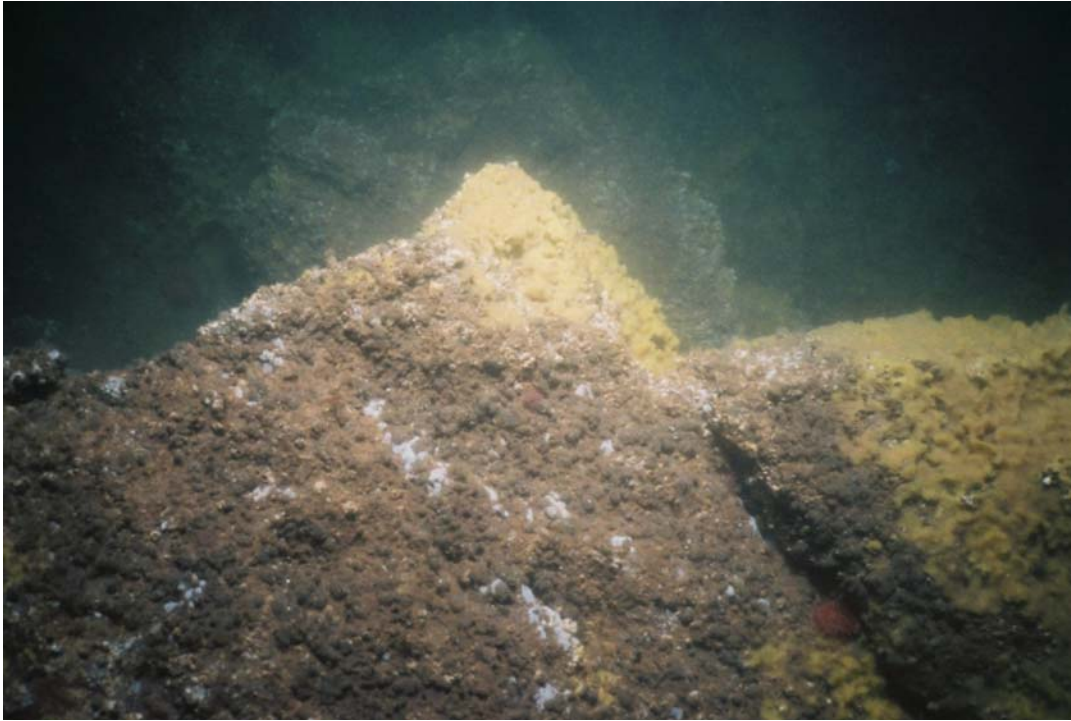
Figure 19. Volcanic bedrock prominence with encrusting sponge and ‘biolayer’ similar in appearance to that found on sedimentary bedrock. Red *Stomphia* anemone, edge fauna and some barnacles are also visible.

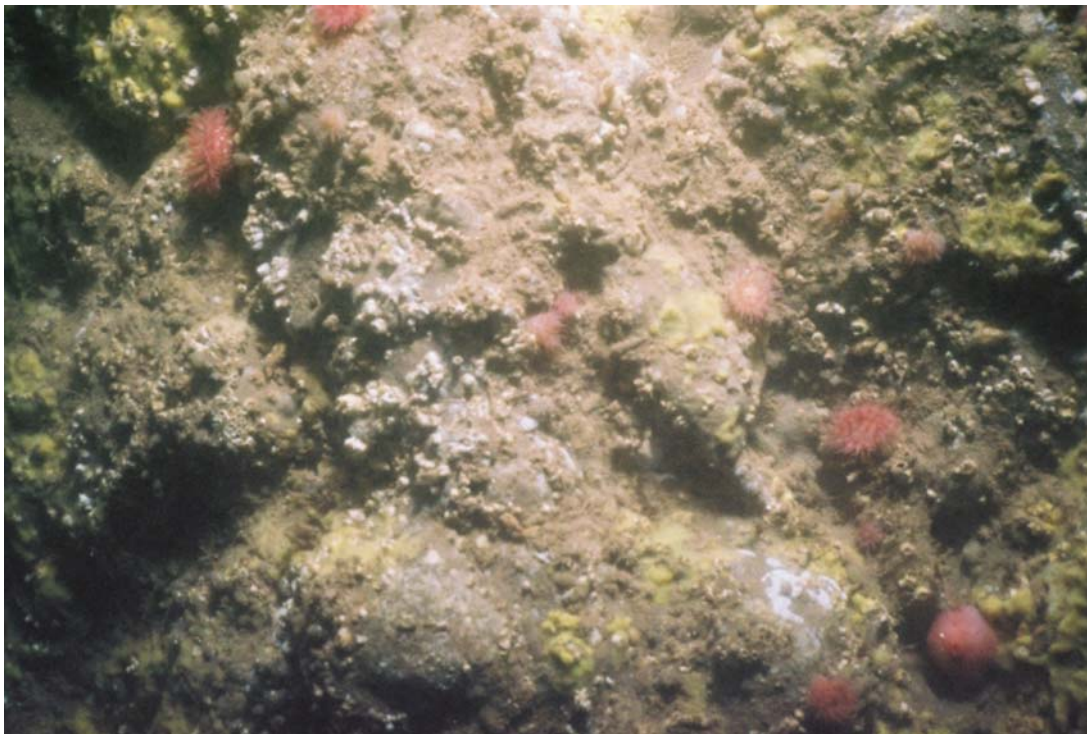
Figure 20. Anemones, sponges, barnacles and biolayer on rough volcanic bedrock.

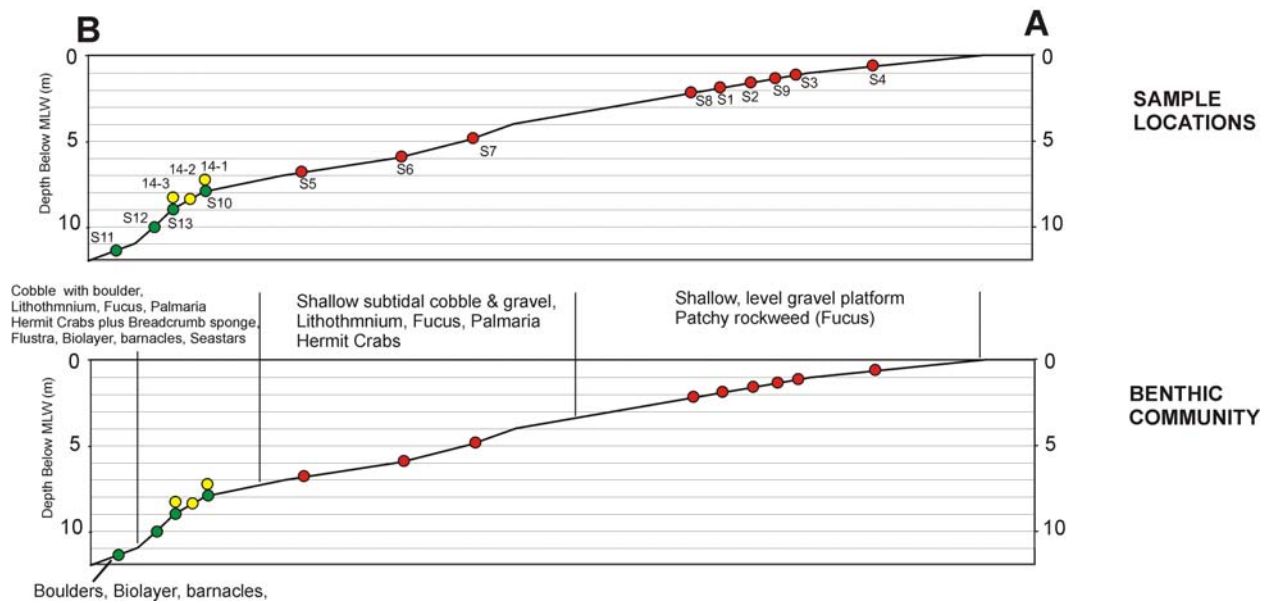
Figure 22. Cross-section of the nearshore shelf in the vicinity of the proposed cable corridor, showing seabed communities. Locations of stations used to determine the zonation for the site are shown in Figure 23.

Distinct biological zonation is observed in a collection of video images extending from mean low water (MLW) to the edge of the nearshore shelf and down the slope to the point where it meets the unconsolidated boulder and cobble zone which characterizes the seabed between the shelf and the offshore bedrock areas (Figures 22-29). On the shelf, the biological community is characterized by occurrence of patches of rockweed (*Fucus* sp)(Figures 24 & 25). Below a depth of about 5 metres below MLW to about 7 m, substrate changes to predominantly cobble which supports several species of seaweeds (*Fucus*, *Palmaria*, and encrusting coralline algae (*Lithothamnium*), and includes hermit crabs (Figures 26 & 27)). Below this area, a mixed zone of cobble and boulder occurs (Figure 28), with a moderate diversity of organisms. This area appears to be productive and continues to support seaweeds such as *Palmaria palmata*. Lower on the shelf, cobble & boulder bottom is dominated by the biolayer community and seaweeds are no longer present (Figures 29-30).

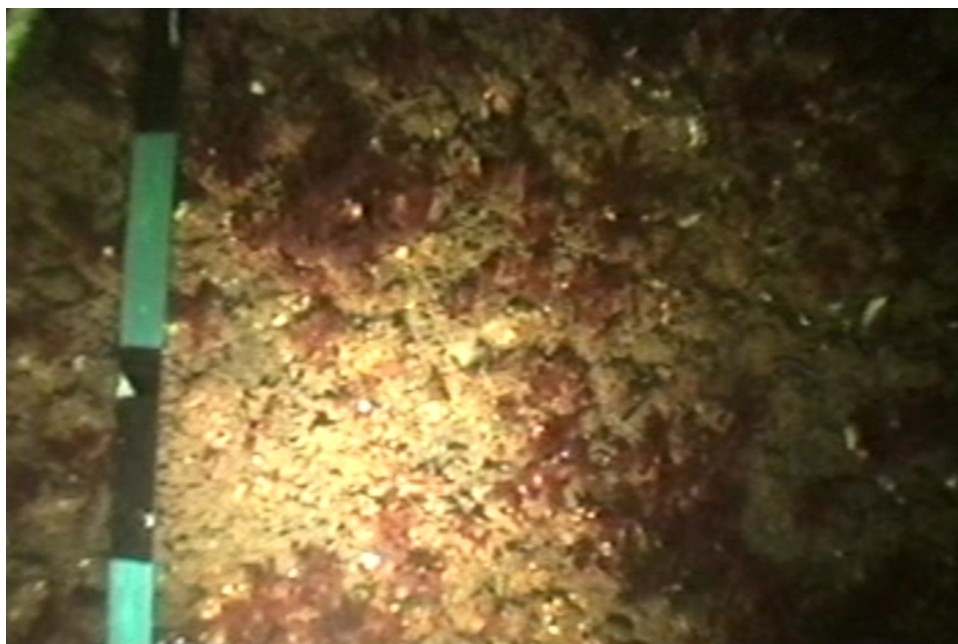
Figure 27. Biological community at Station S10, located near edge of nearshore shelf. Red seaweed, which is visible is dulse, *Palmaria palmata*.

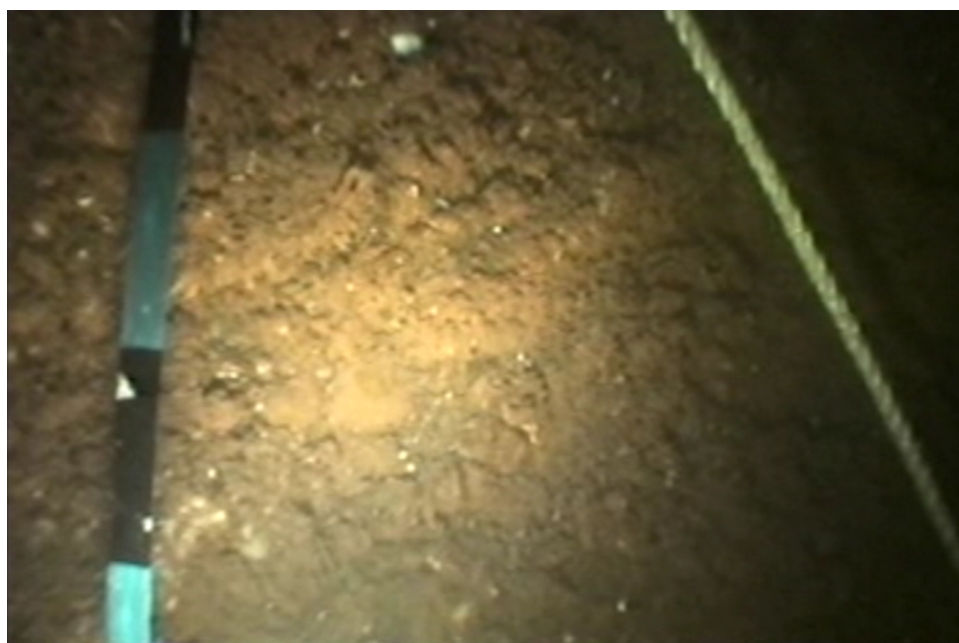
Figure 29. Boulder and 'biolayer' community on a boulder located on the slope of the nearshore shelf, Station S11.

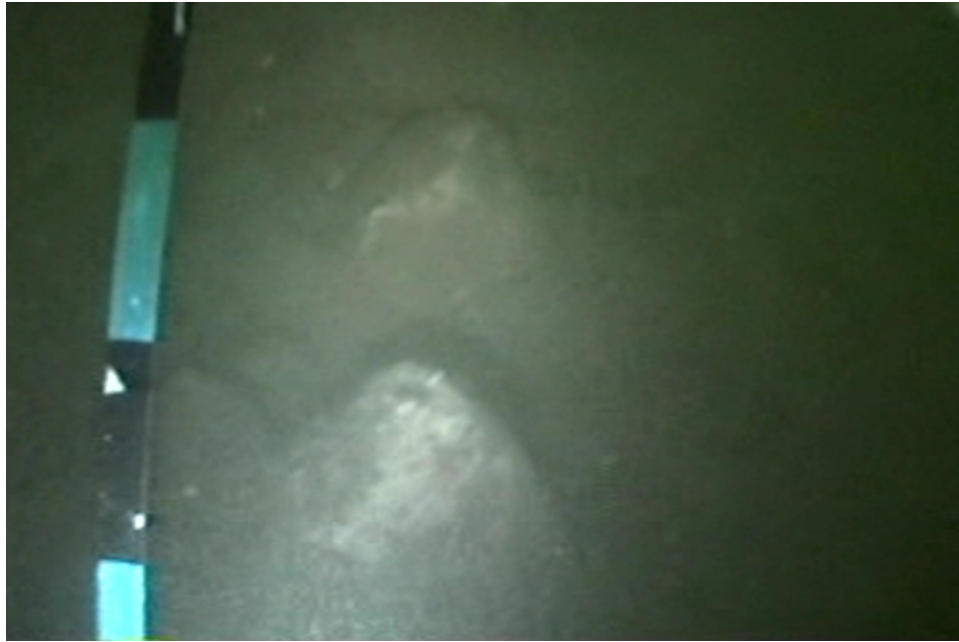
Figure 30. Boulder and cobble on lower slope of nearshore shelf, Station S12.
