Seabed Video and Photographic Survey — Nearshore Cable Route Stations

Minas Passage Tidal Energy Study Site

Based on Survey on
August 4, 2009

MARINE SURVEY REPORT
FUNDY TIDAL POWER RESEARCH AND DEVELOPMENT PROJECT

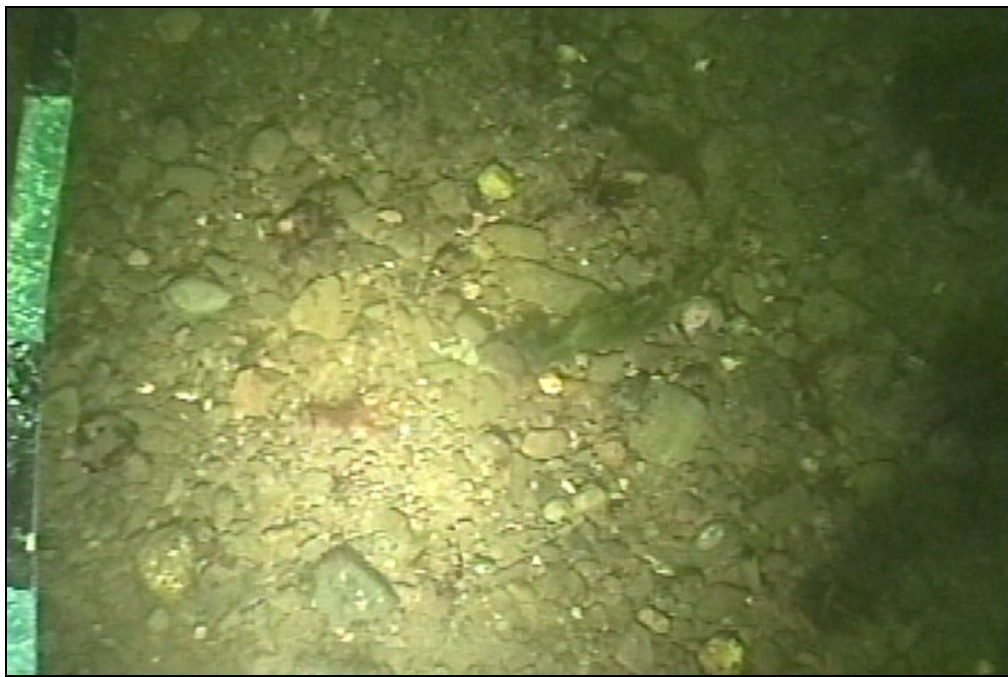
Figure 3. Clean gravel to cobble with attached sea lettuce (*Ulva lactuca*) and *Fucus* sp at Station NC1, August, 2009. Photo NC1-1B, Appendix A.

From inshore to offshore at the site, substrate changes from level, predominantly gravel bottom with cobbles present (Stations NC1 & NC2) (Figures 3-5) to increasing occurrence of clean, well-sorted cobbles and boulder (NC3 & NC4) (Figures 6-8). The outer edge of the shelf (Station NC5) has a mixed character, predominantly cobbles and small boulder, but including a gravel and sand fraction (Figures 9 & 10). Bottom types reflect the distribution observed on the shelf in 2008 (Envirosphere Consultants Limited 2008a & b), which included sites west of the study site (Figure 2).

Immediately below Mean Low Water (MLW) (Station NC1 and extending through Station NC2)(Figure 2), a reduced biological community including rockweed (*Fucus* sp) and sea lettuce (*Ulva lactuca*) occurs on well-sorted gravels, interspersed with a low density kelp bed (*Laminaria longicruris*) consisting of scattered fronds of *Laminaria* attached to embedded cobbles, as well as clumps of rockweed (*Fucus* sp) (Table 1) (Figure 3), and the kelp *L. digitata* (Figures 4 & 5). Further seaward, at depths of 3-5 m below MLW, seaweeds including *Fucus* sp., *Palmaria palmata* (dulse) and coralline algae (*Lithothamnium*) encrusting on rocks, occur (Figures 6-8). At the deepest site (NC5) the erect bryozoan *Flustra foliacea* (an animal), *Palmaria*, and encrusting coralline algae (*Lithothamnium* sp.) were dominant community components; slipper shells (*Crepidula* spp.) were also common video from the site. Although few animals were seen in the video, the animal community on the shelf likely includes common species for the area, such as hermit crabs (*Pagurus* sp), rock and green crabs, etc., as well as various smaller species, which cannot be seen in video images.

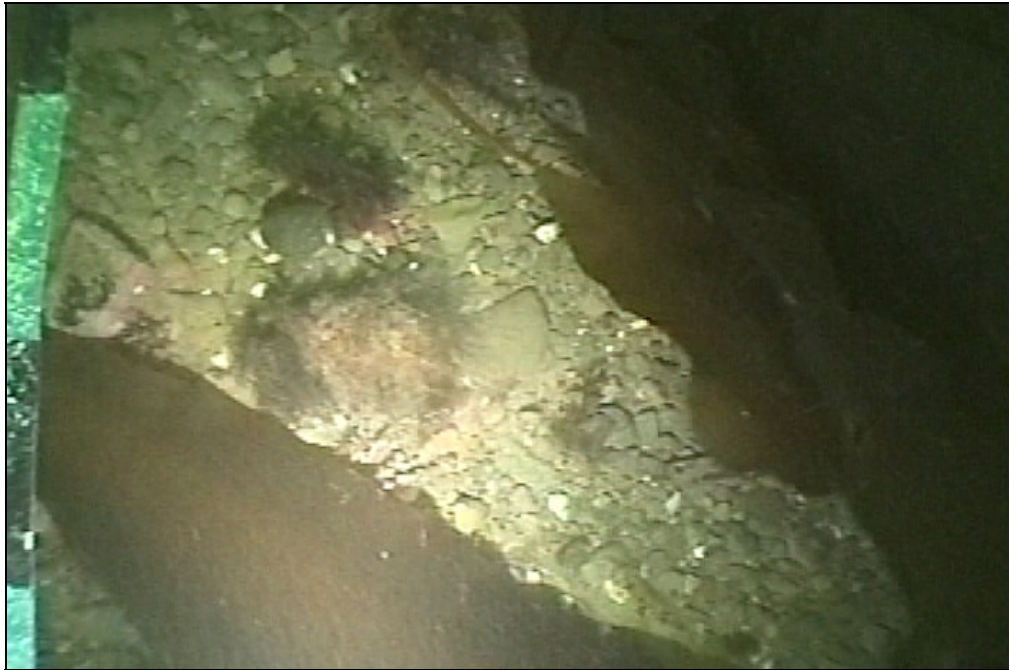
Figure 4. Kelp (*Laminaria longicuris*), coralline algae, and *Fucus* sp , Station NC1-2B, Appendix A.

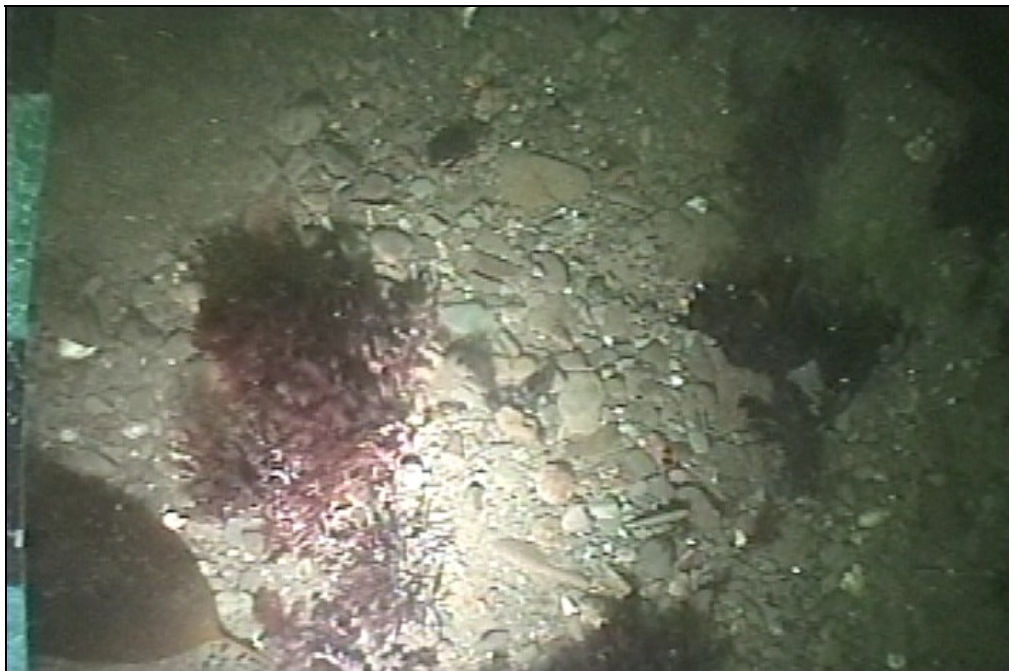
Figure 5. *Laminaria* sp. and *Fucus* sp. over gravel to cobble bottom at Station NC2-3B.

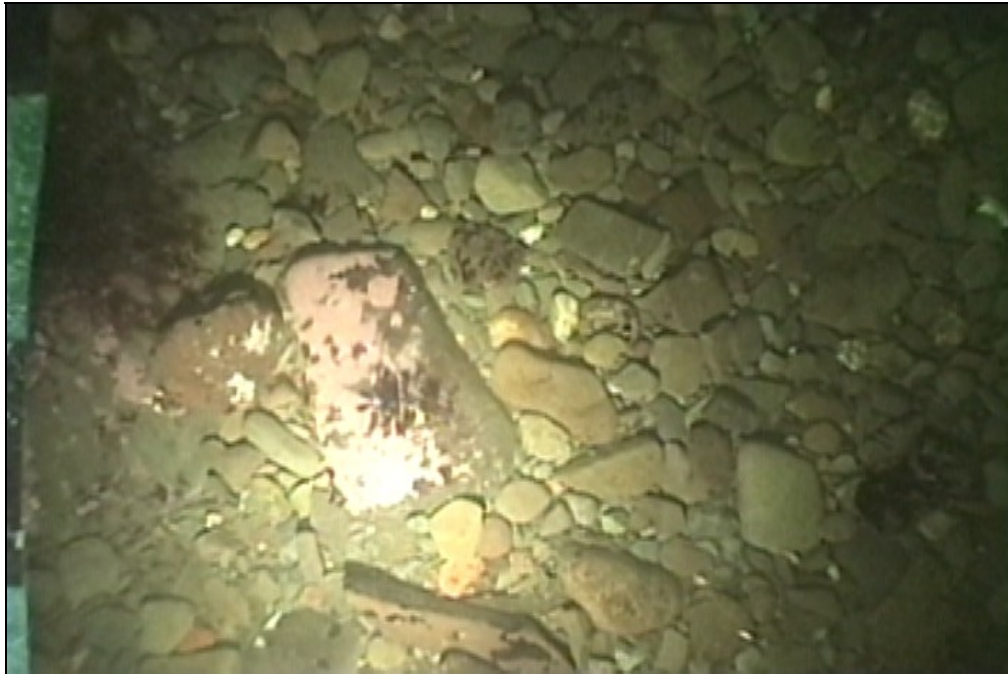
Figure 6. Cobble to boulder bottom at Station NC3. *Fucus* sp and coralline algae on rocks. Photo NC3-1B, Appendix A.

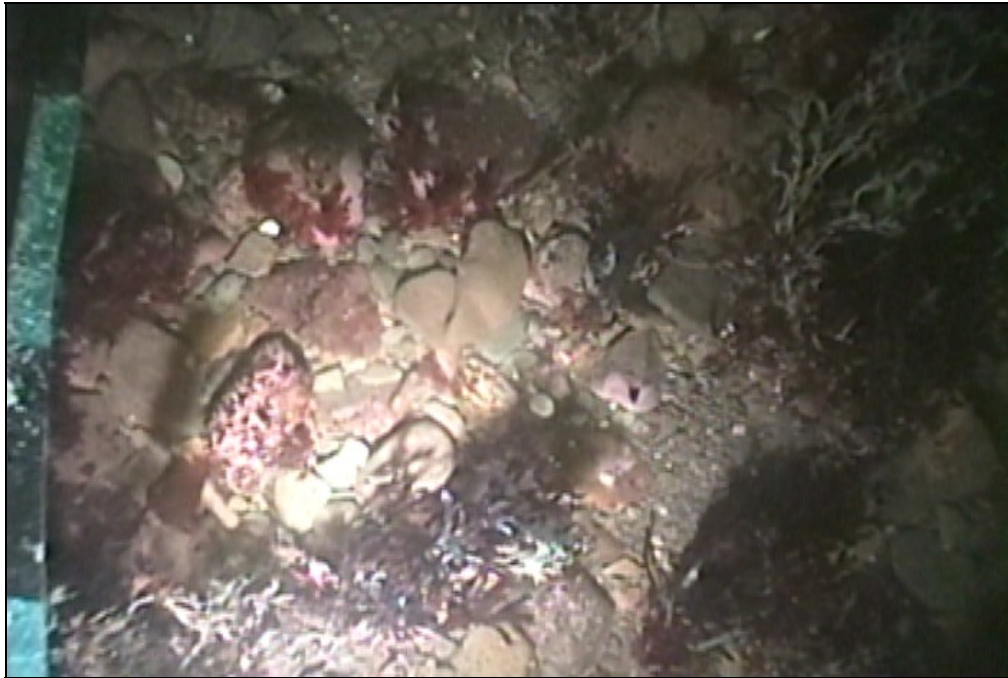
Figure 8. Mixed cobble to boulder bottom with coarse sand and attached seaweed (*Palmaria*), coralline algae, and *Fucus* sp. Station NC4, Photo NC4-3B, Appendix A.

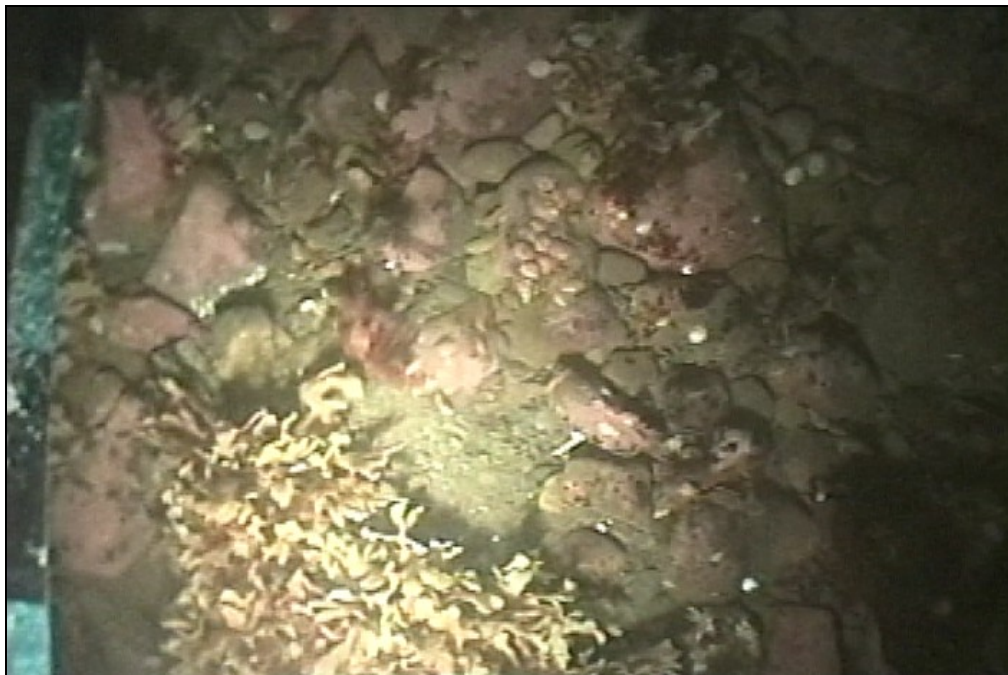
Figure 9. Mixed cobble to boulder bottom with coarse sand, attached *Palmaria*, seaweed *Fucus* sp. and erect bryozoan, *Flustra foliacea*., and Slipper shells, *Crepidula* sp on rocks. Station NC5. Photo NC5-1B, Appendix A.

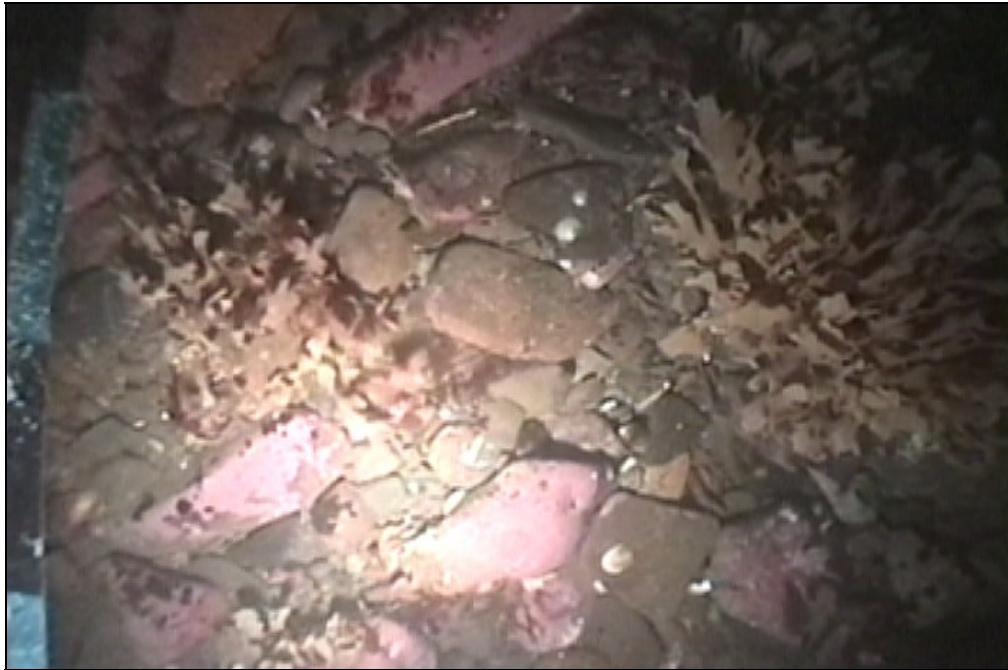
Figure 10. Cobble bottom with attached erect bryozoans, *Flustra foliacea*, encrusting coralline algae, *Palmaria*, and slipper shells, *Crepidula* sp. Station NC5. Photo NC5-2B, Appendix A.
