Seabed Video and Photographic Survey — Berth “A” and Cable Route

Minas Passage Tidal Energy Study Site

Based on Surveys on
July 2-3 and August 4-5, 2009

MARINE SURVEY REPORT
FUNDY TIDAL POWER RESEARCH AND DEVELOPMENT PROJECT

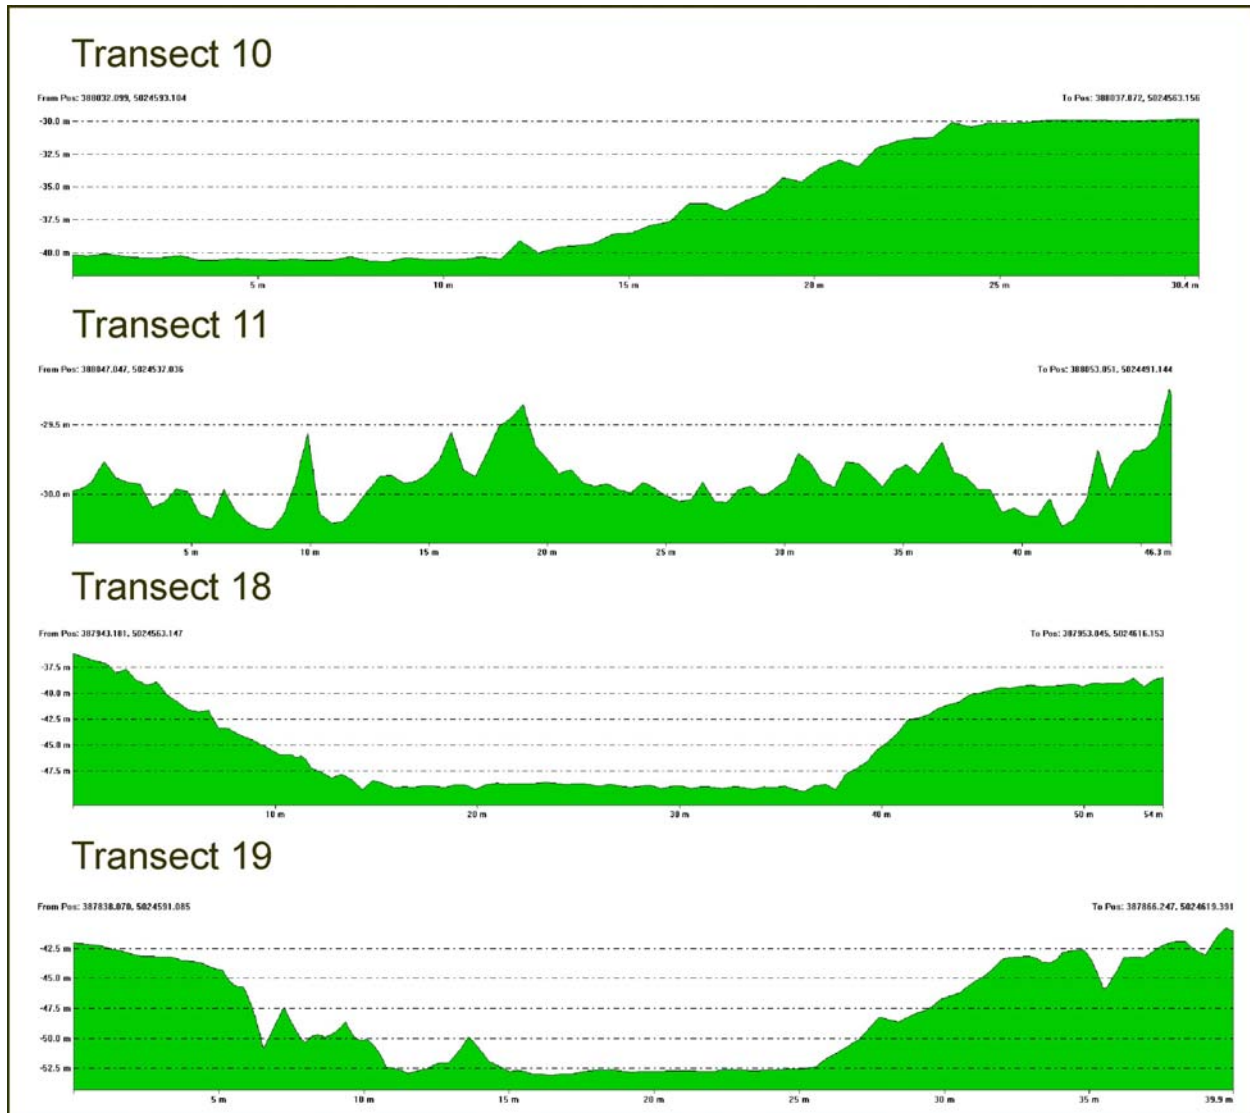
Figure 3. Cross sections in the vicinity of Berth “A”. For locations, see Figure 2.

The Berth “A” site is level with microtopography largely due to the presence of boulders (Figures 2 & 3, Transect 11)[Note: The low vertical exaggeration for cross section Transect 11, shown in figure 3, compared to other cross sections, shows relief on the scale of 0.5 to 1 m.]. The scarp at the northern edge of Berth “A” has a steep, 1:1 slope (Transect 10, Figure 3).

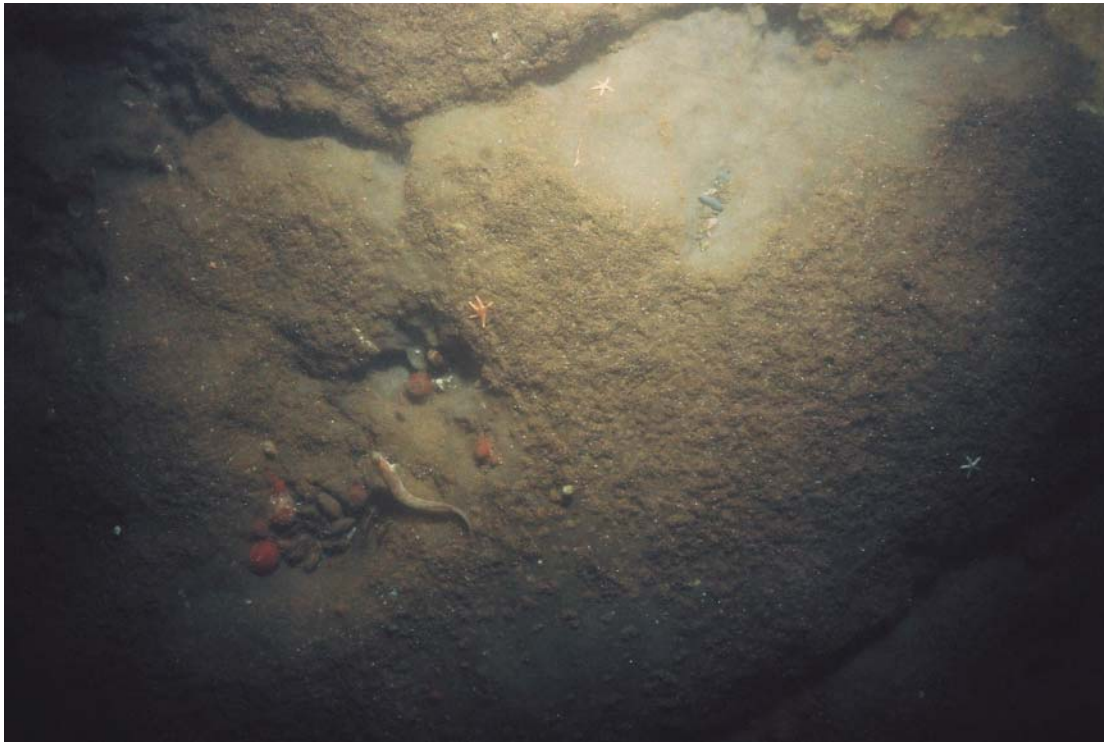
Figure 4. Exposed basalt with fractures and pits at Berth “A”. Image includes a fish (Daubed Shanny), attached mussels, Northern Red Sea Anemone, Blood Star (*Henricia sanguinolenta*) and unidentified seastars as well as ‘biolayer’ of attached organisms. Location BEN A11, Appendix B, July 3, 2009. Vertical dimension of image = 1 m.

Biological Communities—Biological communities resembled those sampled in the 2008 survey (Table 1)(Figures 4-7). The Berth is entirely on the basalt platform, and communities included the same major components as in 2008, including the dominants, the Northern Red Anemone (*Urticina felina*), the yellow, encrusting breadcrumb sponge (*Halichondria panicea*) and the red, blood star (*Henricia sanguinolenta*). A surface covering of tubes of benthic organisms (‘biolayer’)(also observed in 2008, one of two types of ‘biolayer’, this one associated with volcanic bedrock) occurred frequently, and as well hermit crabs and the sea star *Asterias vulgaris*. Clumps of attached mussels (probably *Modiolus modiolus*) in depressions in the bedrock, and the occurrence of Daubed Shanny (*Lumpenus maculatus*) (fish) in two images, were new observations for the site.

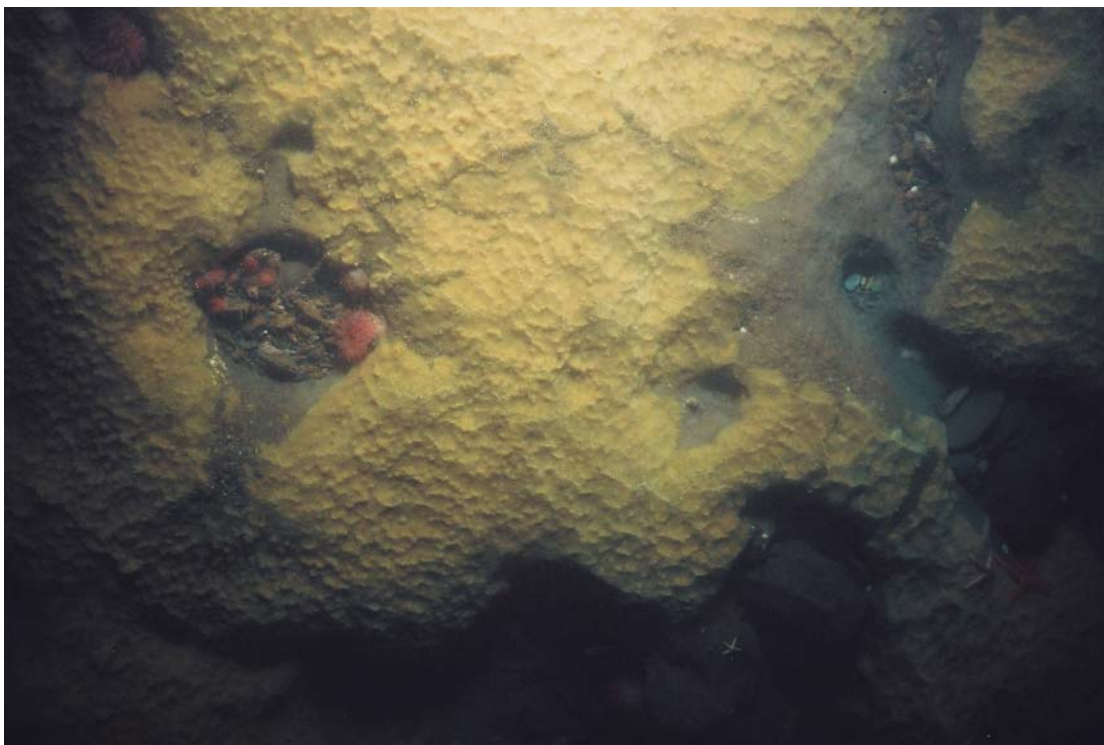
Figure 5. Basalt bedrock, Berth “A”, Station BEN-A11-2, July 3, 2009. Rock encrusted with breadcrumb sponge, with mussels and Northern Red Sea Anemone in pits. Vertical dimension of image = 1 m.

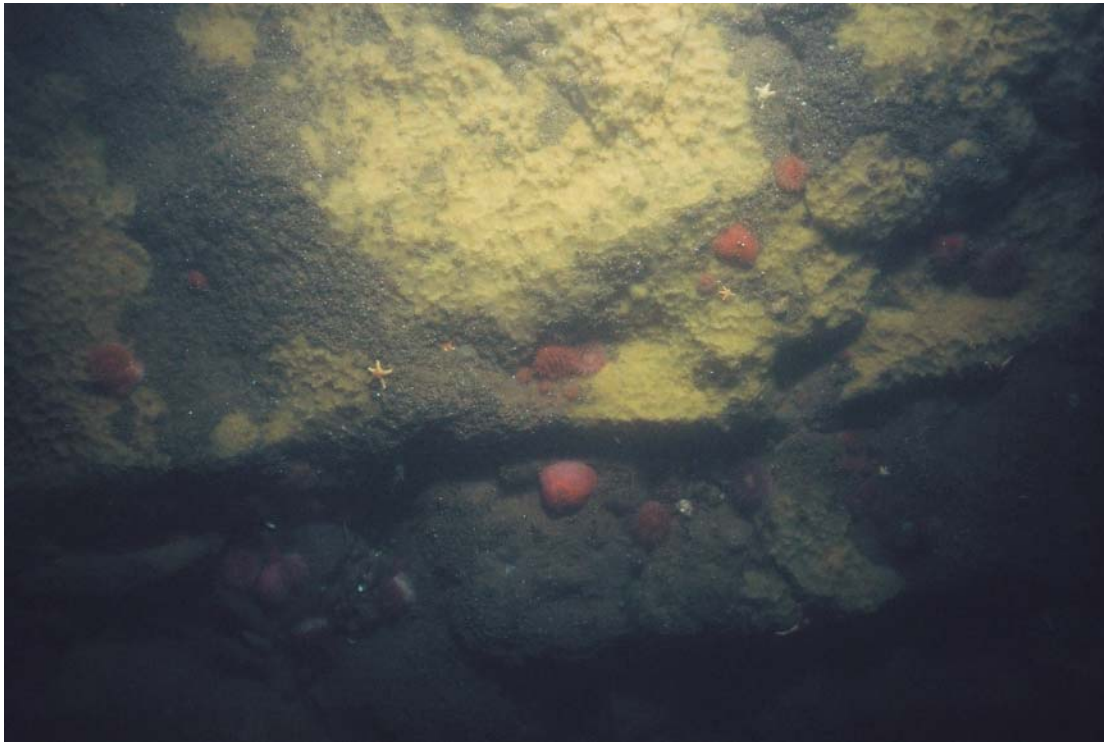
Figure 6. Bedrock at Berth “A” (Station BEN-A11-4, Appendix B), with encrusting sponge, surface ‘biolayer’, Northern Red anemones, and seastars, July 3, 2009. Vertical dimension of image = 1 m.

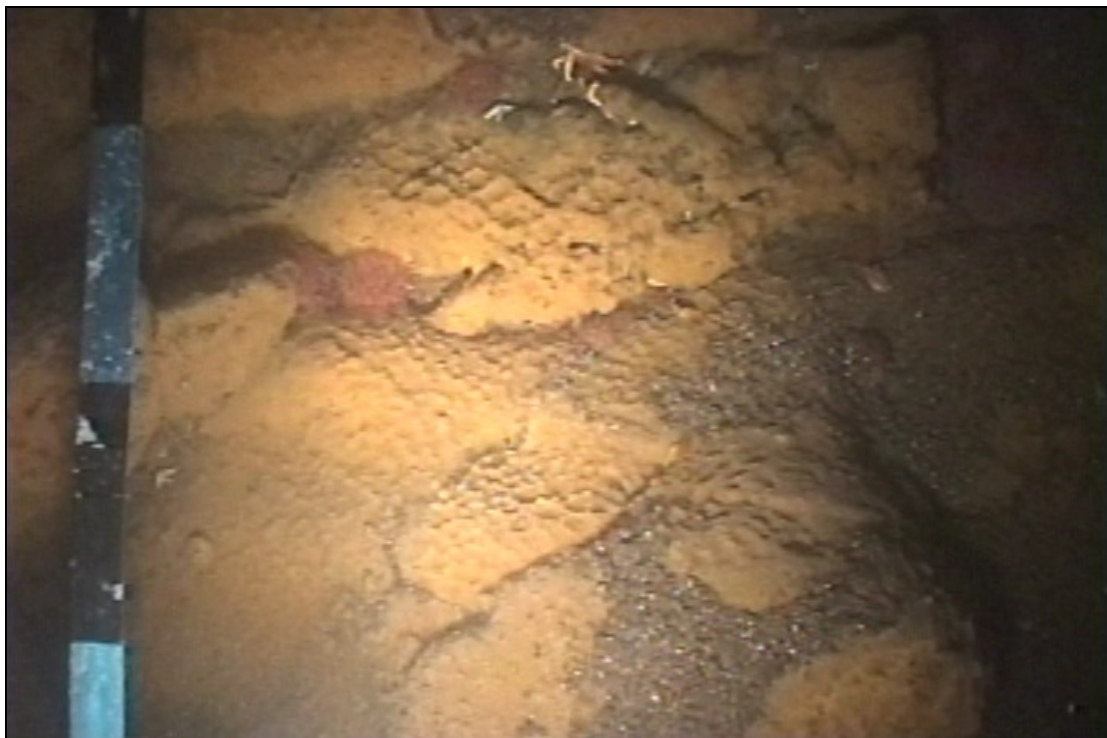
Figure 7. Basalt bedrock at Berth “A”, showing rounded surface with fractures, breadcrumb sponge, and Northern Red Anemone (Station A7-2-C, July 2, 2009, Appendix A). Unit on scale bar = 10 cm.

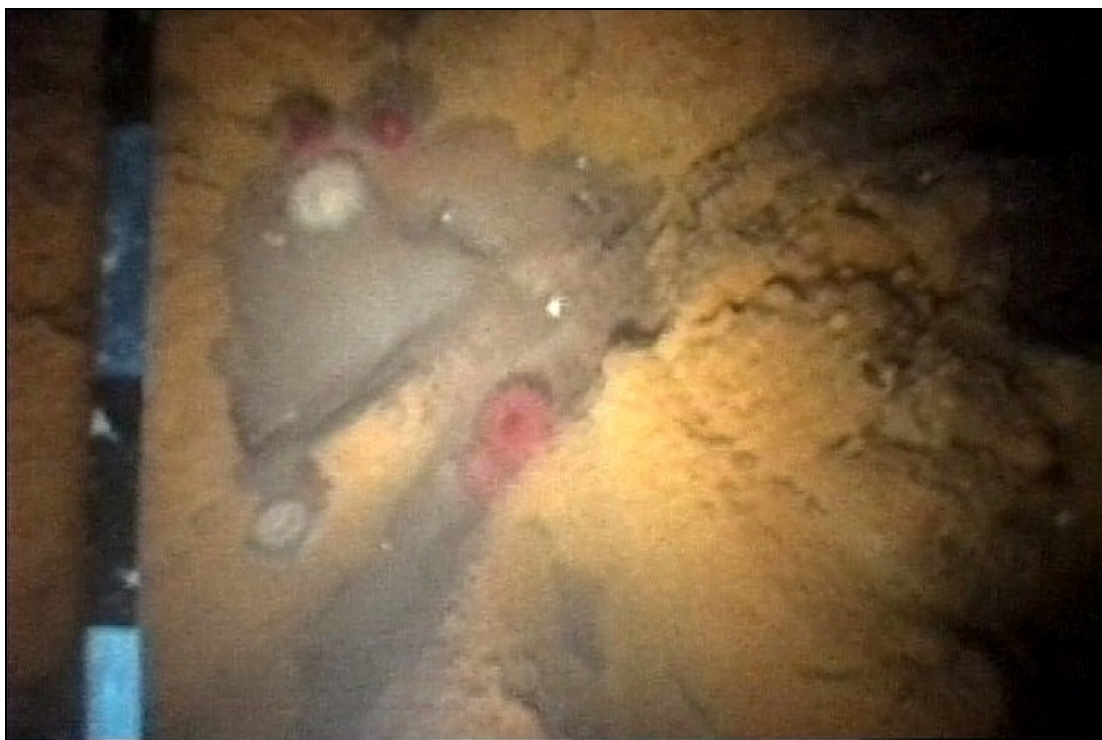
Figure 8. Basalt bedrock and attached organisms, Berth “A” cable route Station AC30-2-C (Appendix C), showing encrusting sponges, sea anemones, July 2, 2009.

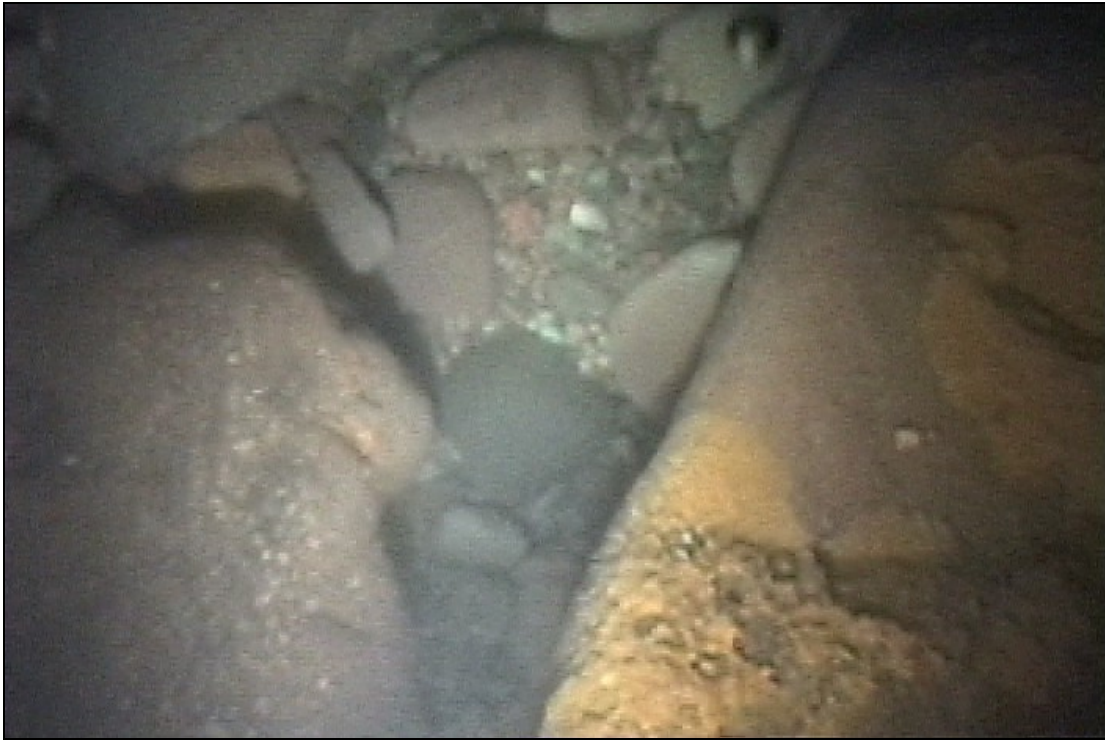
Figure 9. Boulders and cobble over bedrock on top of basalt platform, at Station AC27 on Berth “A” cable Route, July 2, 2009.

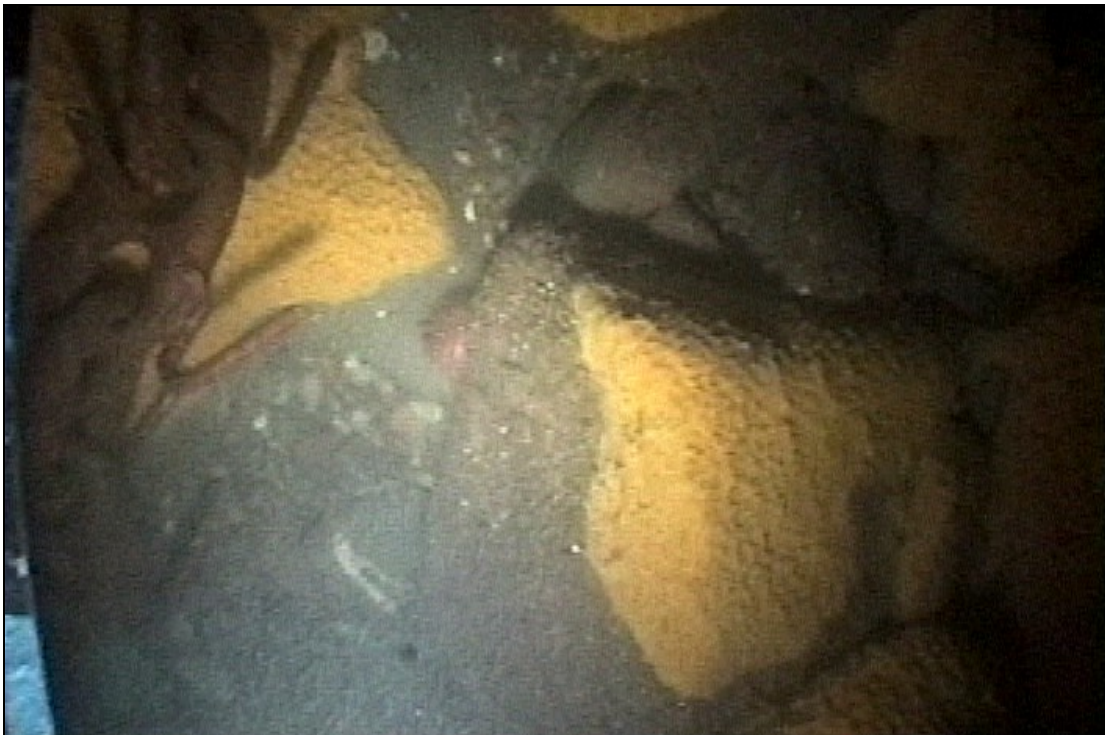
Figure 10. Cobbles and boulders over basalt bedrock along Berth “A” cable route, Station AC22-2, August 4, 2009.

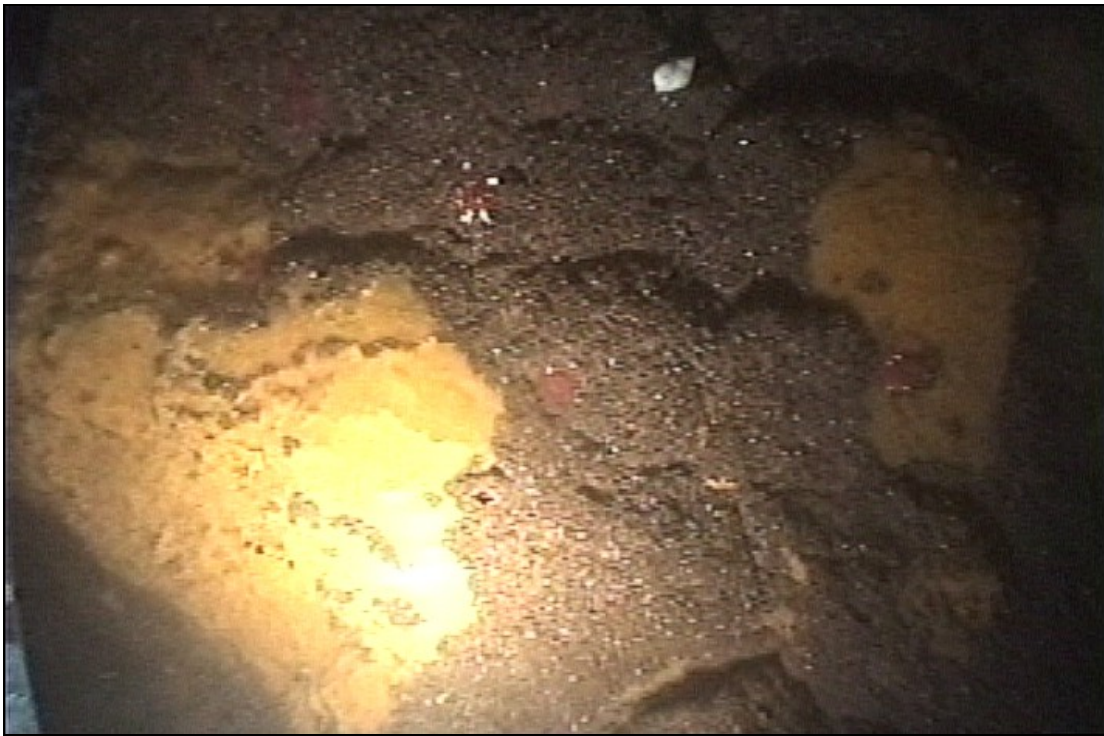
Figure 11. Basalt boulder in transitional area between bedrock platform and cobble to boulder area, Station AC19, August 4, 2009.

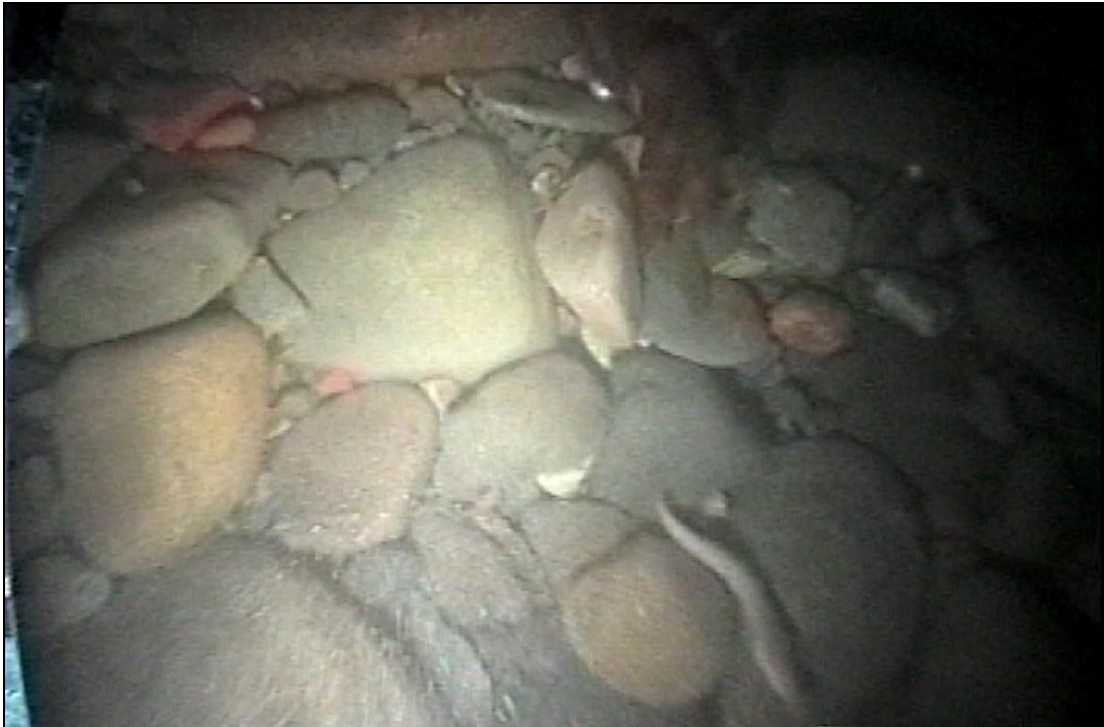
Figure 12. Transitional area between the bedrock platform and cobble-boulder bottom aalong cable route, west of Black rock, (Station AC18-1), August 4, 2009.

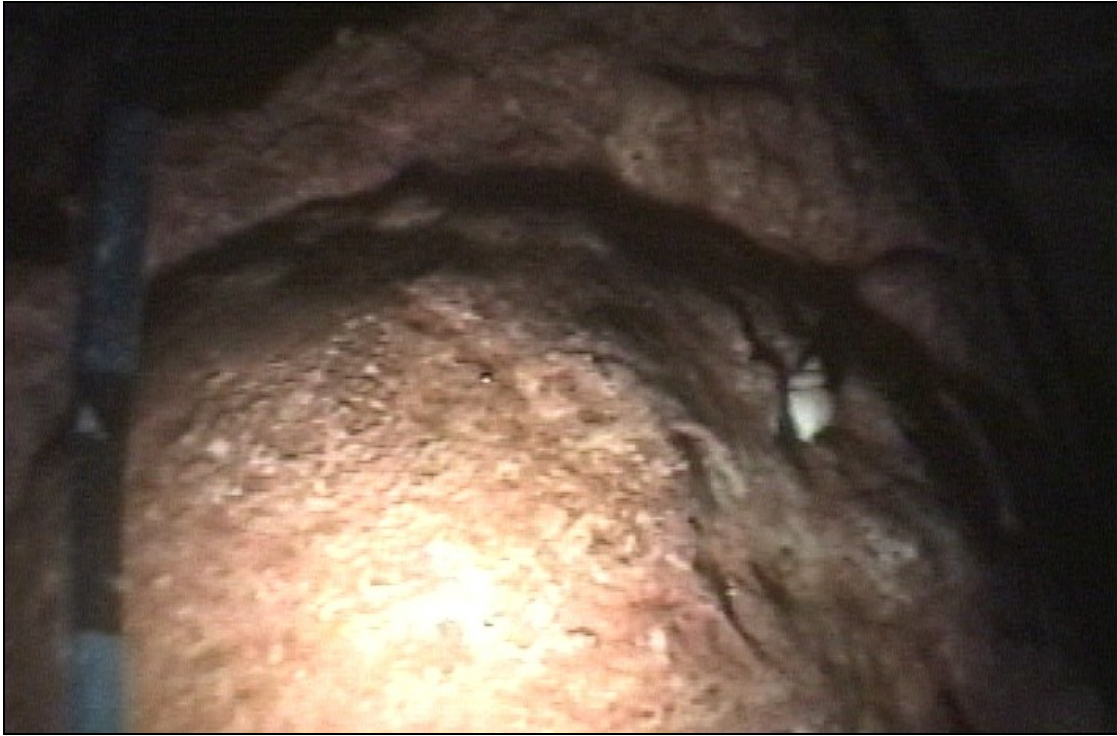
Figure 13. Boulder with attached hermit crab (in snail shell), Station AC13-2, July 2, 2009.

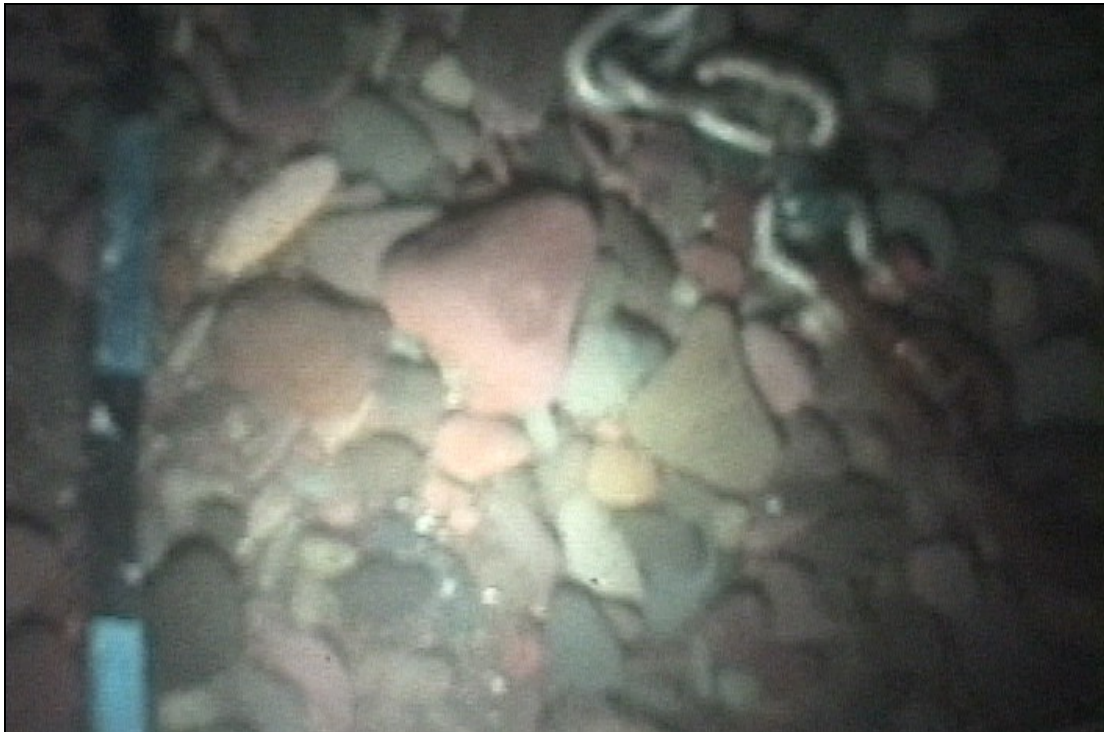
Figure 14. Gravel to cobble wave on seabed west of Black Rock, Station AC11-3, July 2, 2009.

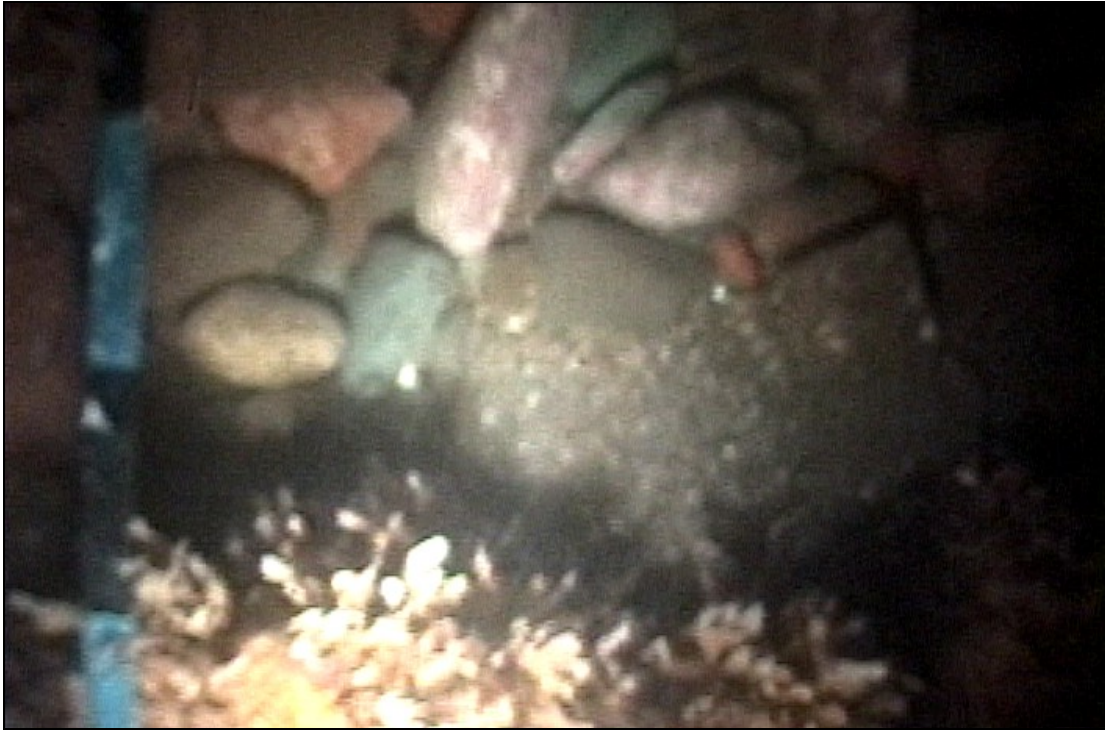
Figure 15. Cobble/boulder bottom west of Black Rock, Station AC10-3, July 2, 2009.

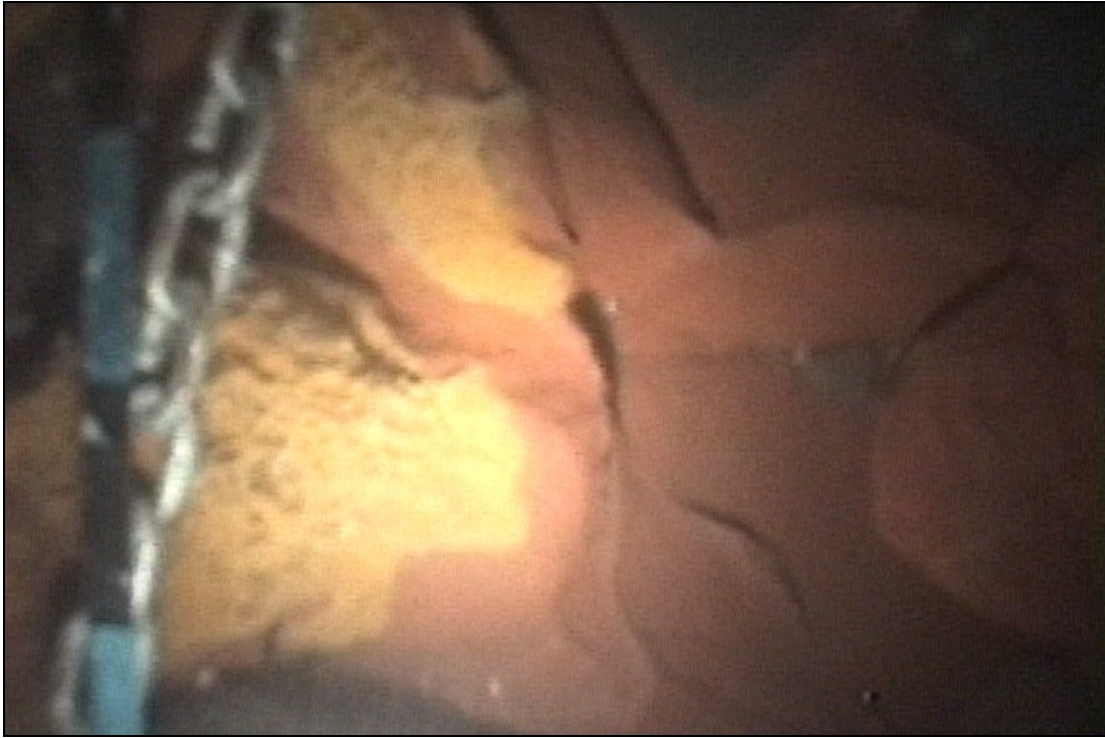
Figure 16. Mudstone bedrock exposure in nearshore trough, encrusted with breadcrumb sponge, Station AC8-3, July 2, 2009.

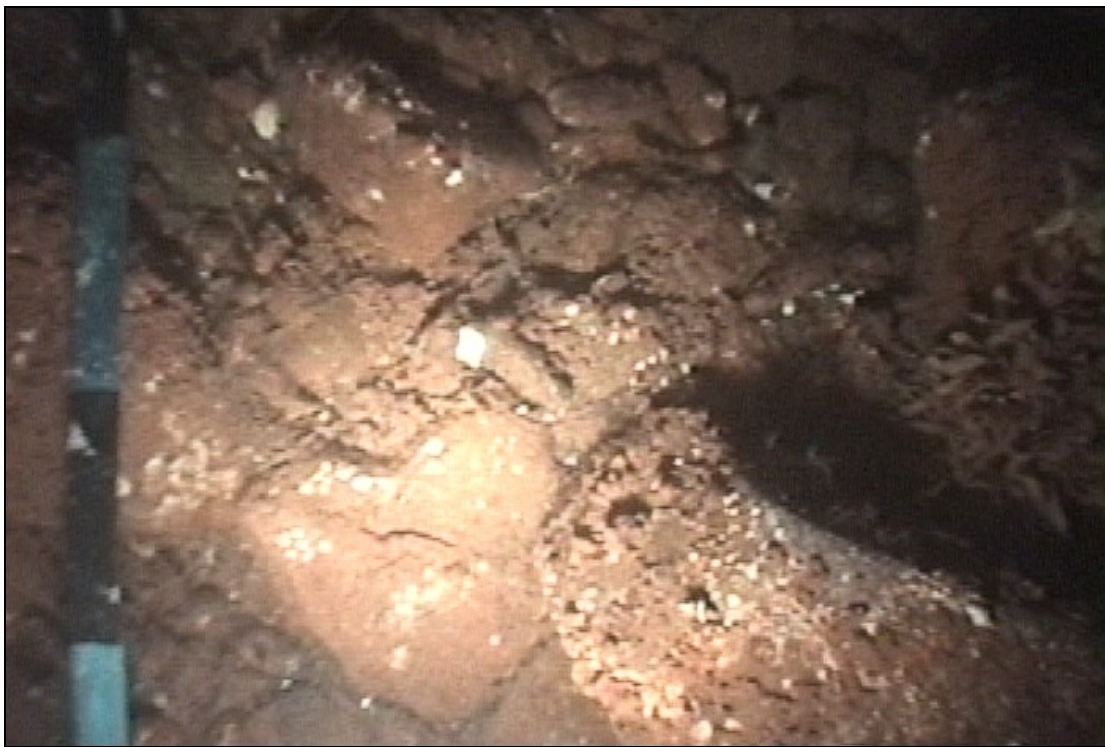
Figure 17. Cobble and boulder bottom on slope of nearshore shelf, showing ‘biolayer’ of tube-building organisms, and attached erect bryozoan (*Flustra*), Station AC3-2, July 2, 2009.

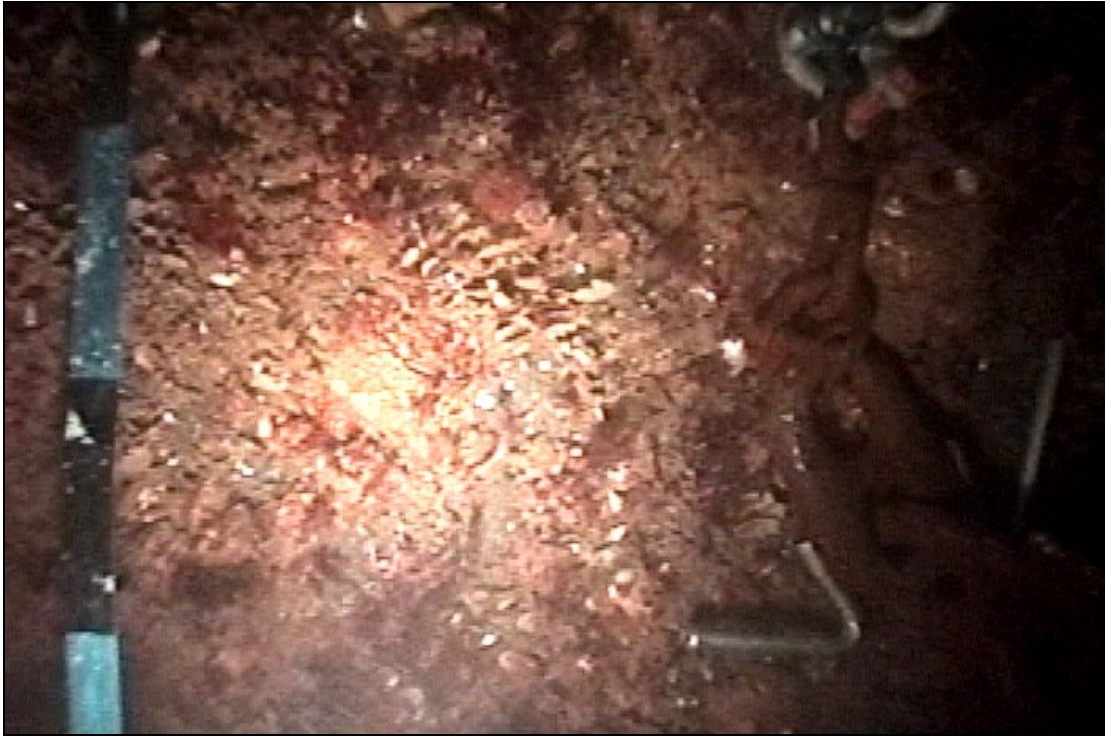
Figure 18. Cobble bottom with attached red algae (*Palmaria palmata*), coralline algae and *Flustra foliacea*, Station AC1-2, July 2, 2009.

(Figure 18)(imagery from the shallower water on the shelf is contained in the companion report for Berth “C”). The shelf is described in baseline studies from 2008 (AMGC 2009; EnviroSphere Consultants Ltd. 2009; Stewart (2009))³.

Biological Communities—Biological organisms characteristic of the basalt bedrock as described for Berth “A” above, were observed along the cable route where it runs over the basalt platform. Typical species include Northern Red Anemone, Blood Star, Breadcrumb sponge encrusting on rocks (Figure 18), and occasional occurrences of seastars (*Asterias* sp.) and hermit crabs. Few organisms were observed on cobble/boulder bottom, particularly where the gravel & cobble as well as gravel waves predominate, but the biological community was similar to that observed in earlier surveys in the adjacent areas to the west, including occasional breadcrumb sponge on the tops of boulders, and the occasional occurrence of mobile species such as hermit crabs (Table 1), and a fish (Station AC18, Figure 12). Breadcrumb sponge occurred more frequently in the trough between Black Rock and the nearshore shelf, where boulders and bedrock exposures were more common, and particularly barnacles and edge fauna (the erect bryozoan, *Flustra foliacea*) occurred (Figure 15). Cobbles and boulders on the slope of the shelf supported a “biolayer” of organisms at the surface, as well as attached organisms such as *Flustra*. The outer edge of the shelf where the survey ended was occupied by coralline algae and short dulse (*Palmaria palmata*) (Figure 18).
