## Seabed Video and Photographic Survey — Berth "B" and Cable Route

### Minas Passage Tidal Energy Study Site

Based on Surveys on July 2-3 and August 4-5, 2009

MARINE SURVEY REPORT FUNDY TIDAL POWER RESEARCH AND DEVELOPMENT PROJECT

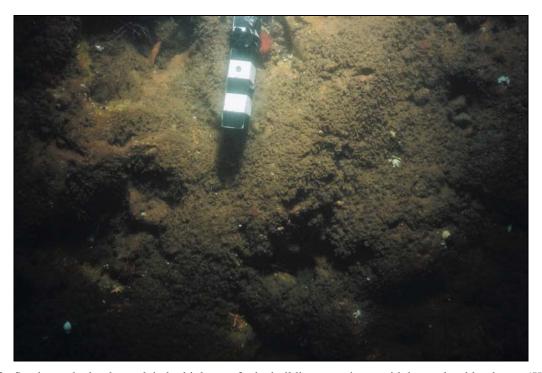
Figure 3 . Sandstone bedrock overlain by biolayer of tube building organisms, with barnacles, blood stars (*Henricia sanguinolenta*), juvenile sea stars, hermit crabs (in snail shells). Station BEN-B17-1, July 2009, Appendix B. Scale units are 2 cm.

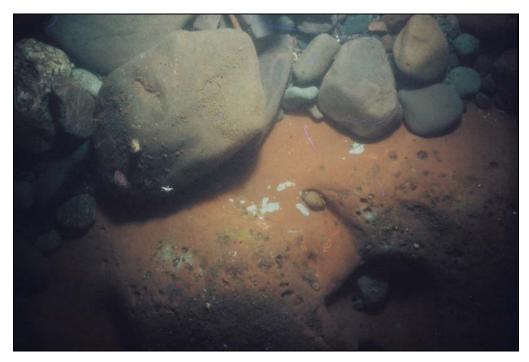
Figure 5. Mudstone bedrock with pitting and depressions, and attached snail, seastar, and northern red anemone, at Berth "B", Station BEN-B13-5, July 2009, Appendix B. Vertical dimension of photo is ~1 m.

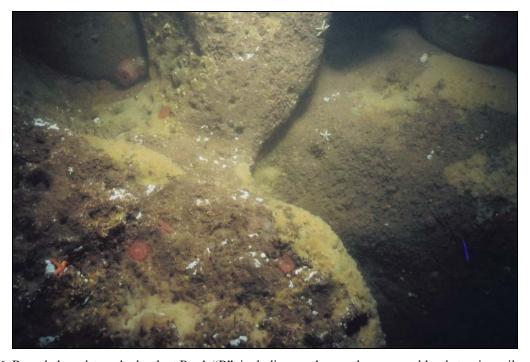
Figure 6. Rounded sandstone bedrock at Berth "B", including northern red anemone, blood star, juvenile seastars, breadcrumb sponge, 'biolayer' and barnacles. Station BEN-B13-6, July 2009, Appendix B. Vertical dimension of photo is  $\sim 1$  m.

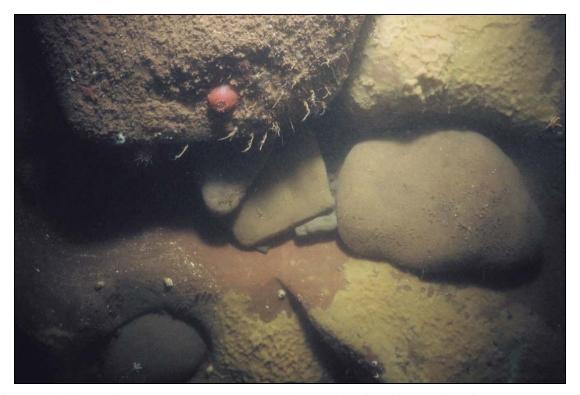
Figure 7. Cobbles and boulders on exposed mudstone bedrock, showing 'biolayer' including tubes on edge of boulder, yellow breadcrumb sponge, northern red anemone, juvenile seastars, barnacles, hermit crabs and snails, Station BEN-B13-3, July 2009. Vertical dimension of photo is ~ 1 m.

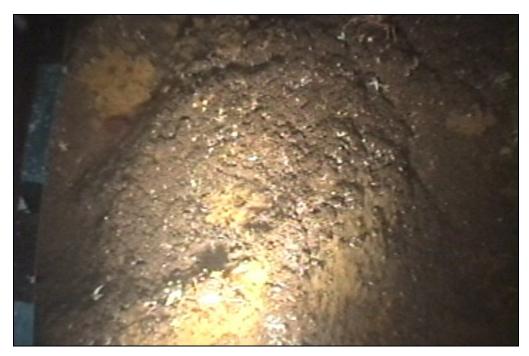
Figure 8. Sandstone bedrock at Berth "B", covered in 'biolayer' of tube-building organisms, patches of breadcrumb sponge (yellow), northern red anemone and juvenile seastars. A toad crab (*Hyas* sp) is at the top of the photo.

Station B13-2-B, Appendix A. Scale units are 10 cm.

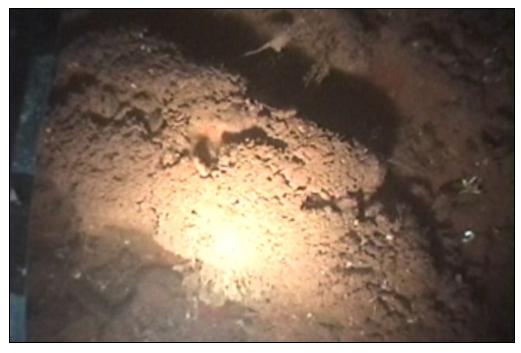
Figure 9. Sandstone bedrock at Berth "B" with 'biolayer' juvenile seastars, and attached 'edge fauna' of organism tubes. Station B13a-2-B, Appendix A. Scale units are 10 cm.

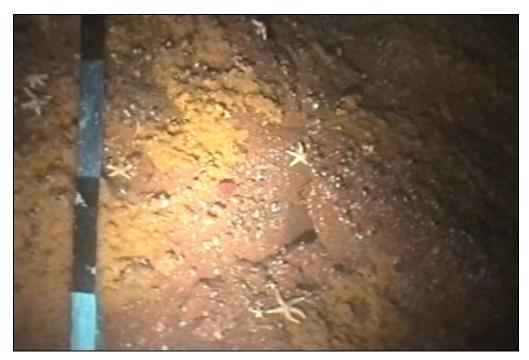
Figure 10. Mudstone bedrock at Berth "B", with juvenile seastars, blood stars, northern red anemone, barnacles, and breadcrumb sponge. Station BJ12-12-B, Appendix A. Scale units are 10 cm.

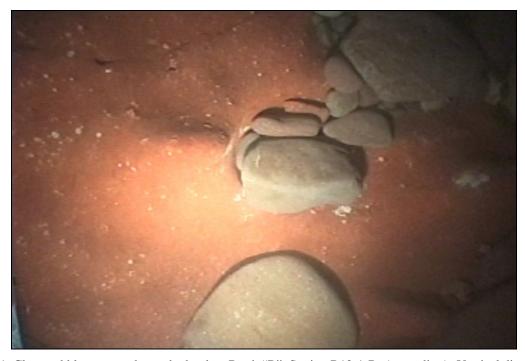
Figure 11. Clean cobble over mudstone bedrock at Berth "B". Station B12-1-B, Appendix A. Vertical dimension of image is  $\sim 30$  cm.

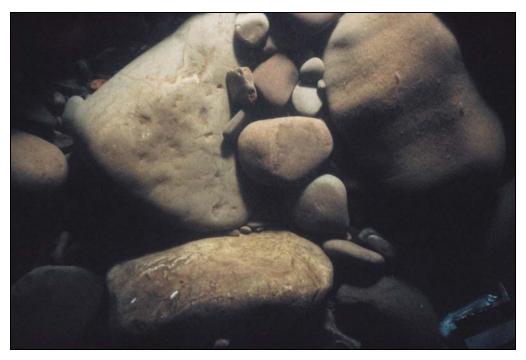
Figure 12. Clean cobble to boulder in trough between bedrock ridges at Berth "B", Station BEN-B13-2, July 2009, Appendix B. Vertical dimension of image is ~ 1 m.

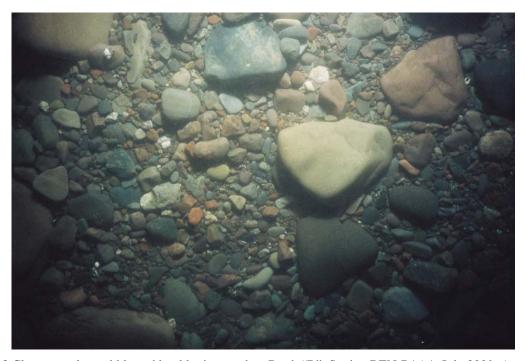
Figure 13.Clean gravel to cobble and boulder in trough at Berth "B", Station BEN-B16-1, July 2009, Appendix B. Vertical dimension of image is  $\sim 1$ m.

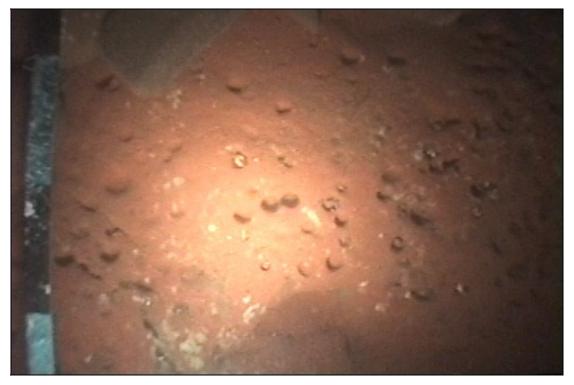
Figure 14. Boring clam burrows in mudstone bedrock along cable route at edge of Berth "B", Station BC42-1-B, Appendix C. Scale units are 10 cm.

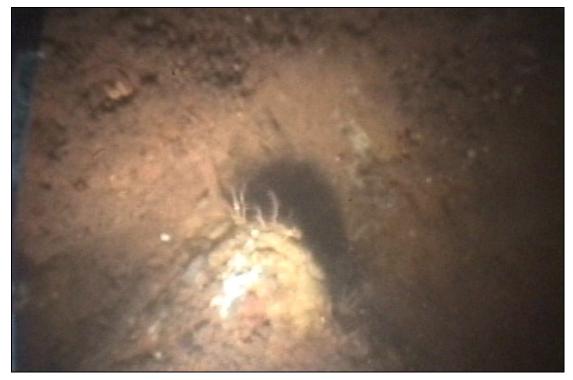
Figure 15. Exposed sandstone bedrock with 'biolayer' and other tube-building organisms along cable route, near Berth "B" (Station BC38-3-B, Appendix C). Vertical dimension of image is ~ 30 cm.

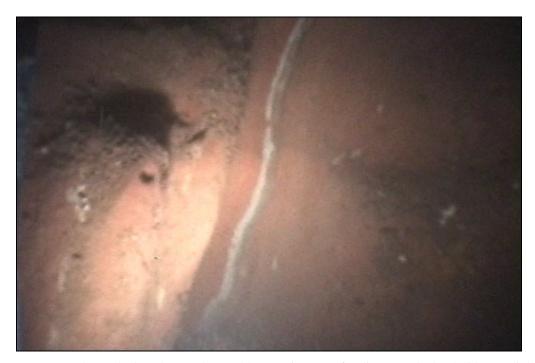
Figure 16. Exposed, streaked mudstone along cable route in zone of sedimentary bedrock ridges. 'Biolayer' occupies some surfaces. Station BC31-3-B, Appendix C. Vertical dimension of image is ~ 30 cm.

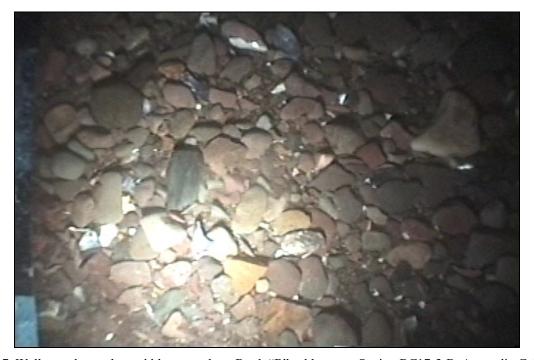
Figure 17. Well sorted gravel to cobble wave along Berth "B" cable route, Station BC17-3-B, Appendix C. Vertical dimension of image is  $\sim 30$  cm.

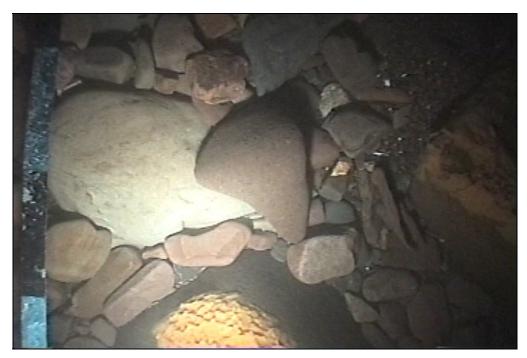
Figure 18. Mixed coarse sand, gravel, cobble and boulder along cable route for Berth "B", Station BC21-3-B, Appendix C. Breadcrumb sponge on basalt boulder shows zone of bedload scour near the seabed. Scale units are 10 cm.

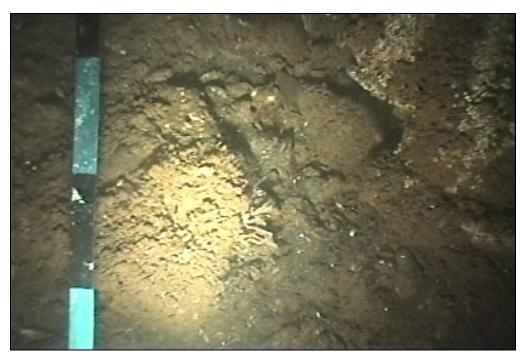
Figure 20. Cobble and boulder bottom on slope of nearshore shelf, showing 'biolayer' of tube-building organisms, and erect bryozoans (*Flustra foliacea*). *Station* BC4-1-B, Appendix C. Scale units are 10 cm.

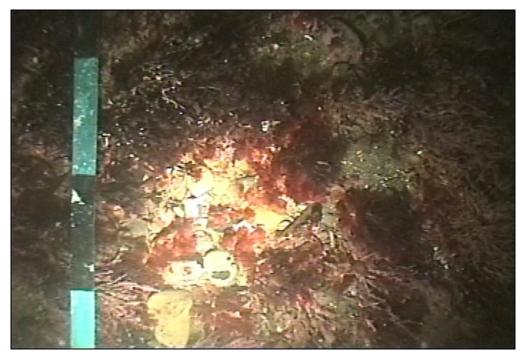
Figure 21. Gravel to cobble bottom with red algae (*Palmaria palmata*) community at about 5 m below MLW near the break in the nearshore shelf. Station BC2-1-C, Appendix C. Scale units are 10 cm.

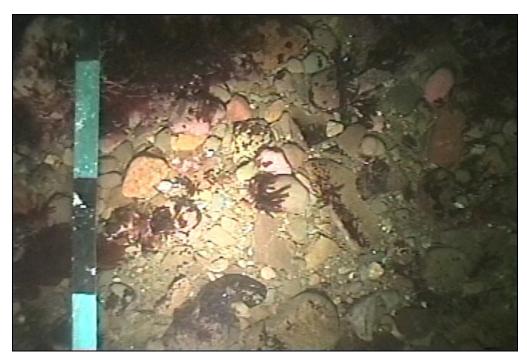
Figure 22. Gravel to cobble bottom on nearshore shelf, at about 2.5 m below MLW, with red algae (*Palmaria palmata*), coralline algae, and possible *Fucus* or *Chondrus*. Station BC1-2-C, Appendix C. Scale units are 10 cm.

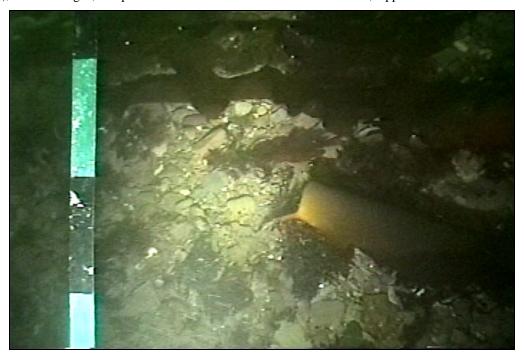
Figure 23. Kelp bed (*Laminaria longicruris* and possibly *L. digitata*). on gravel to cobble bottom on nearshore shelf at about 2.5 m below MLW, including *Fucus* sp and *Palmaria palmata*, Station BC1-1-C, Appendix C. Scale units are 10 cm.
