# Seabed Video and Photographic Survey — Berth "C" and Cable Route

## Minas Passage Tidal Energy Study Site

Based on Surveys on February 2, March 10, June 18 and July 2-3, 2009

MARINE SURVEY REPORT FUNDY TIDAL POWER RESEARCH AND DEVELOPMENT PROJECT

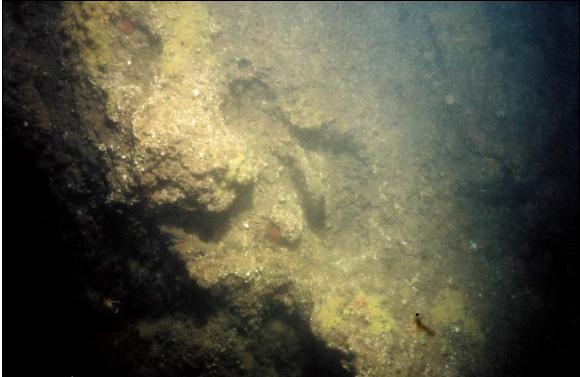
Figure 4. Sandstone bedrock outcrop with northern red sea anemones, blood star, breadcrumb sponge, and toad crab (Hyas sp) (lower left). Location BEN C10-3 (C10-3 (BE)), Appendix E.

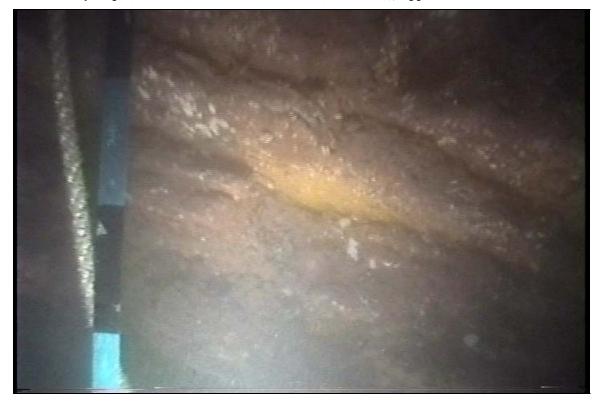
Figure 6. Cobble and boulder over mudstone bedrock exposure, showing layering (Station BEN C-5 (C-5 (BE)), July 2, 2009, Appendix E).

Video and still photographic images were obtained in all the major seabed types at Berth "C". Sedimentary bedrock ridges, particularly sandstone, tended to have rough and irregular surfaces, occasionally showing layering (Figures 4 & 5). Occasional exposures of red mudstone bedrock, with grey layering, occurred in troughs (Figure 6). Areas of cobble and boulder within the site in troughs showed differences in character to those in more open areas outside, with those occurring in troughs between bedrock ridges tending to be more angular (e.g. Stations 3-1 to 3-3, February 2009, Appendix A) and often had biological surface growth of biolayer (tubes and other biological structures on a surface) and small surface dwelling organisms (Figure 7); cobble and boulder areas around the northeast margin of Berth "C" and to the northeast, were generally cleaner, typically without surface growth and occasionally with patchy growth of breadcrumb sponge on boulders (Figures 8 & 9). Overall, areas of cobble and boulder were comparable in character to open areas of cobble and boulder bottom identified in earlier studies at the site and confirm they are extensions of the types observed in the earlier study (e.g. AMGC 2009). The basalt platform on the south side of Berth "C" (Figure 10) showed predominantly boulders encrusted with sponges, similar to those found in earlier studies, although exposed basalt bedrock was not captured in video coverage. The steep escarpment between the volcanic platform and the sedimentary bedrock below was not surveyed in the present study.

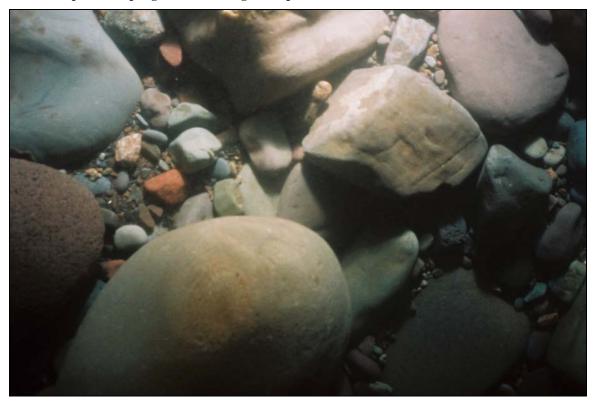
Figure 9. Clean cobble and boulder. Station BEN 6-4 (6-4 (BE)), Appendix E, July 2009.

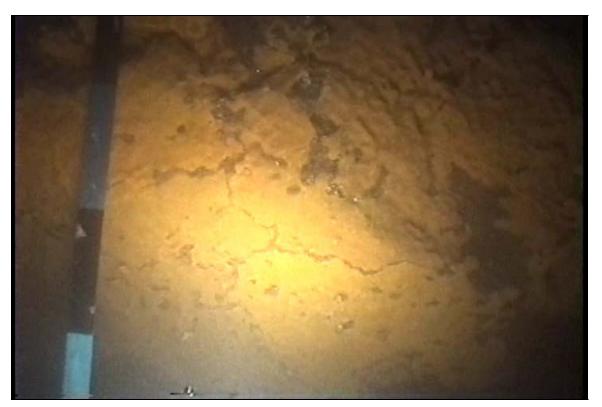
Figure 10. Breadcrumb sponge on volcanic bedrock southeast of Berth C (Station C5-1), February 2009.

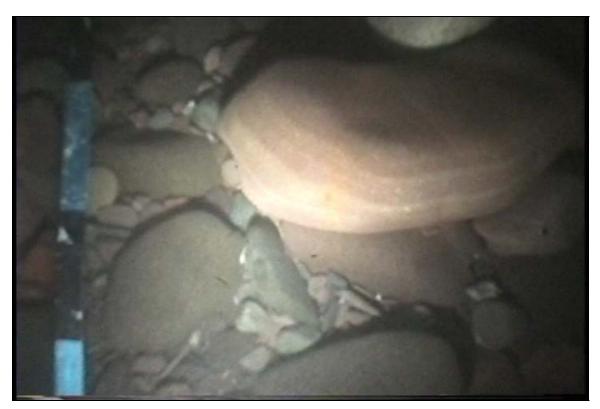
Figure 11. Cobble to boulder bottom, Berth "C" cable route, Station CC16A-1, July 2009.

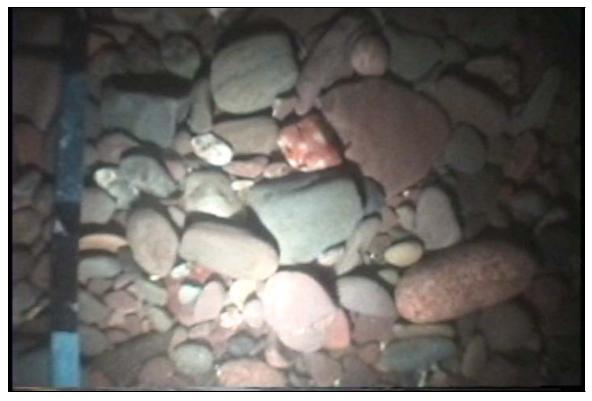
Figure 12. Well sorted cobble, Berth "C" cable route in the vicinity of the bottom shown in Figure (Station CC16A-2, July 2009.
